Service Report

Customer Name: Harris Companies	Marine Job #: ME02382
Contact Person: Ray Lorenzo	Technician: DRAKE CHARLES
Contact Ph: (757) 342 3960	Engine Hours:
Work Location: MANCHESTER TERMINAL	
<u>Service Call Details</u> 7 ENGINES WITH AN INSPECTION ON 3 OF THEM	
Model: C280	Problem Type: INSPECTIONS
Equipment: Generator	Call Type:
Equip/Vessel:	Serial No.: o Port o Starboard NKB00180

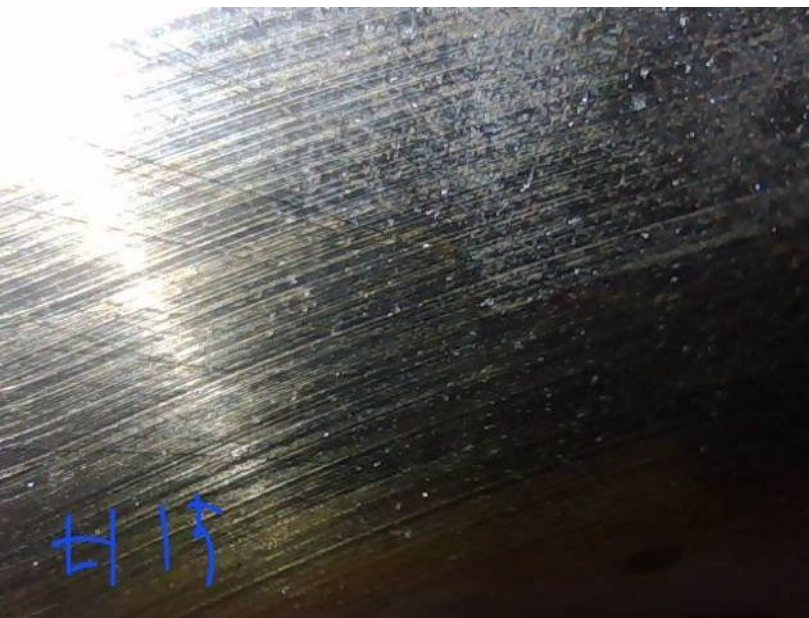
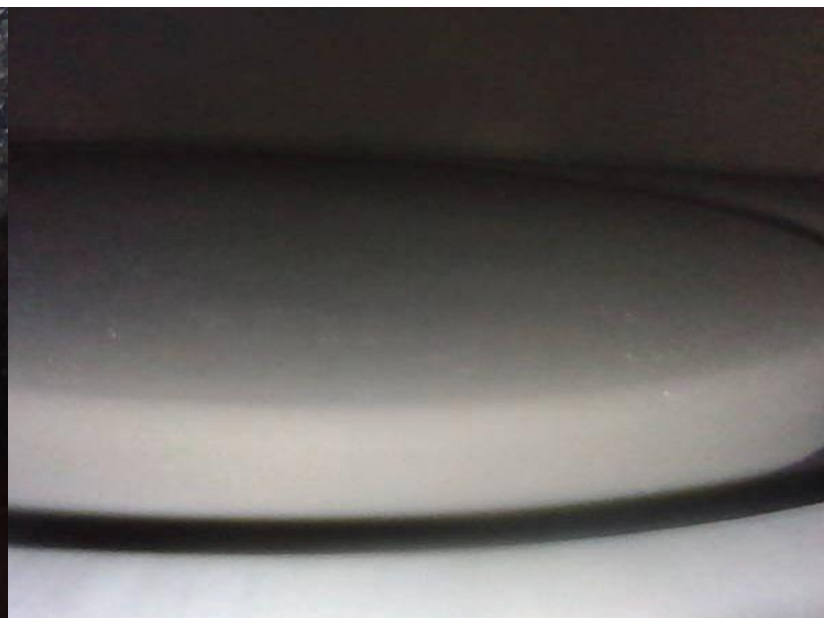
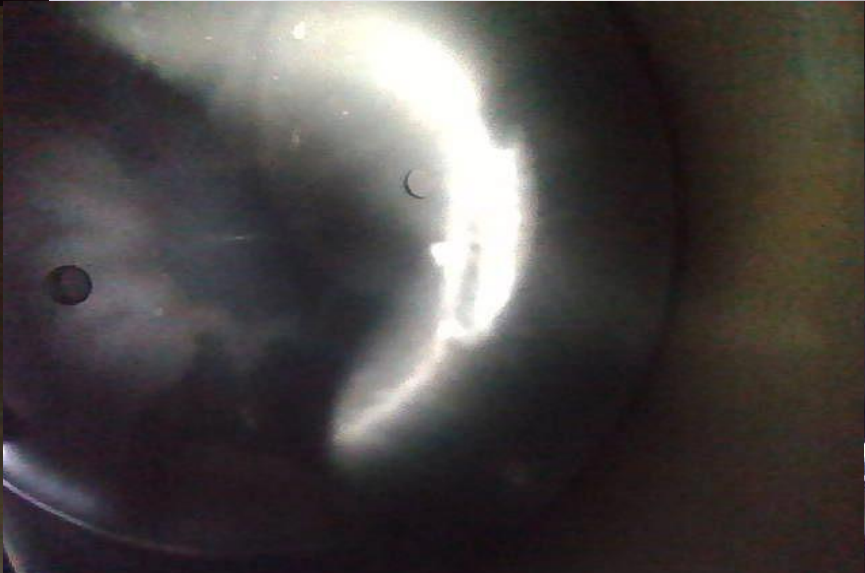
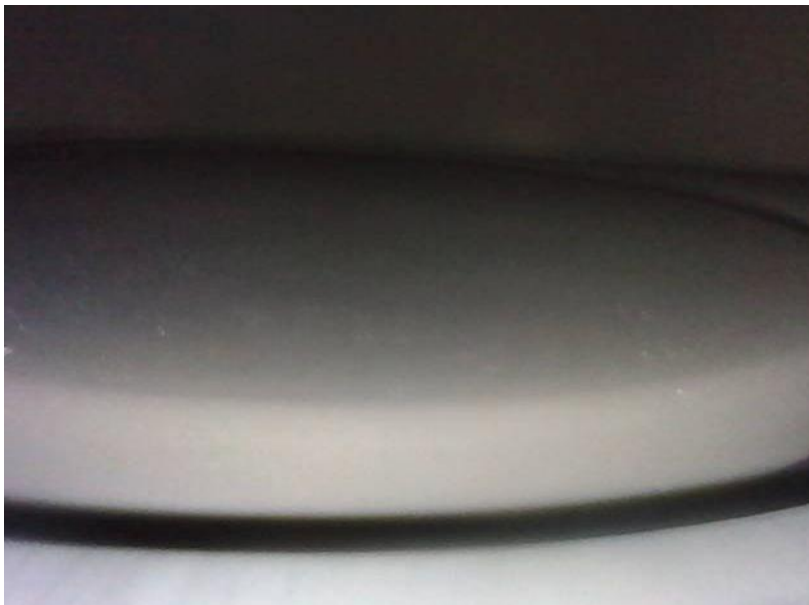
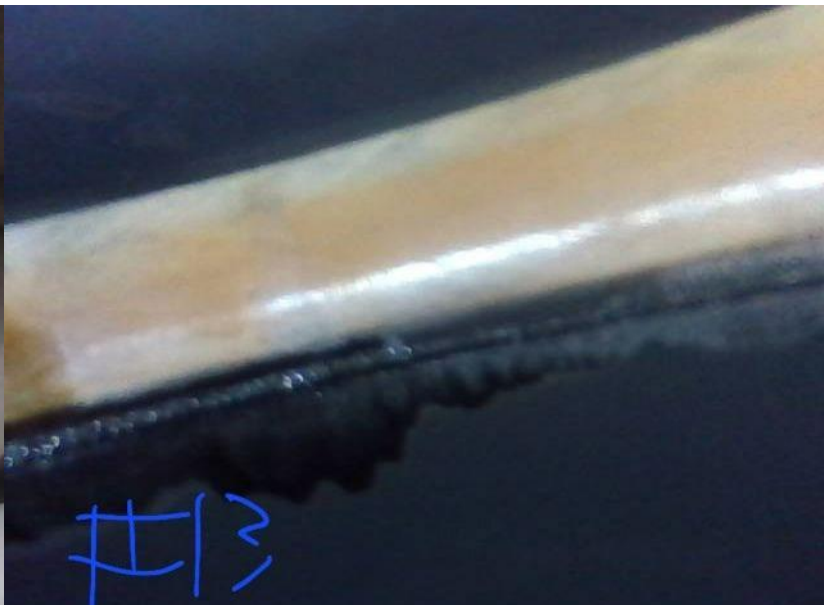
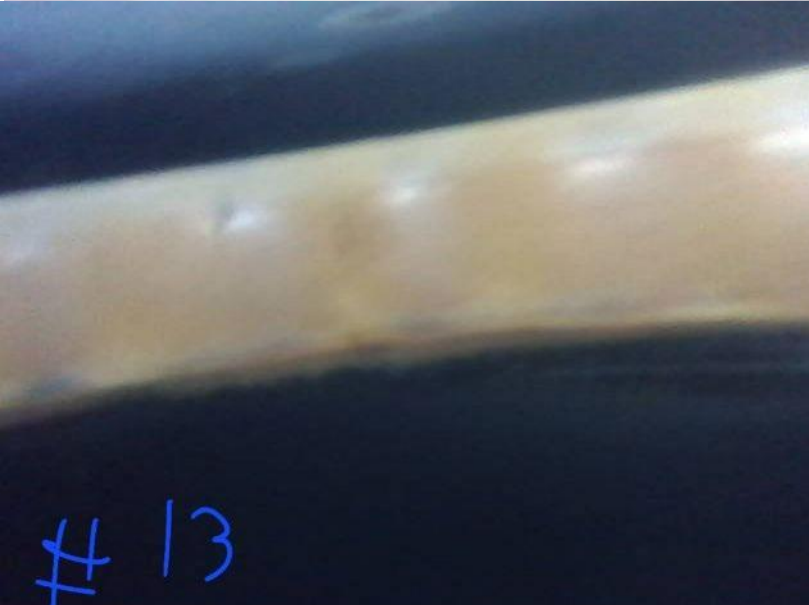
Below you can find pictures showing the cylinder liners, valves, and piston heads, all showing to be in great condition. The crosshatching in the cylinder liners is in good condition, all valves look to be seated properly, and there are no markings or debris sitting on top of the pistons.

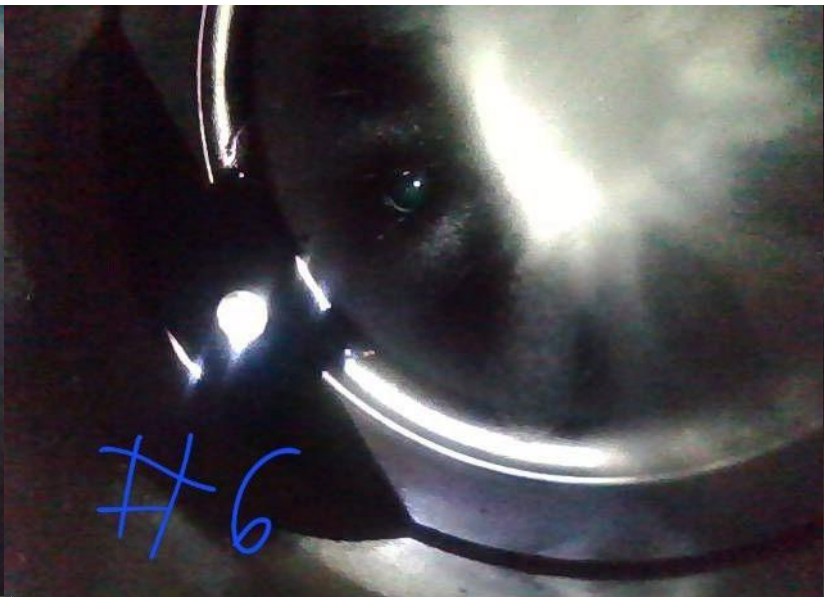
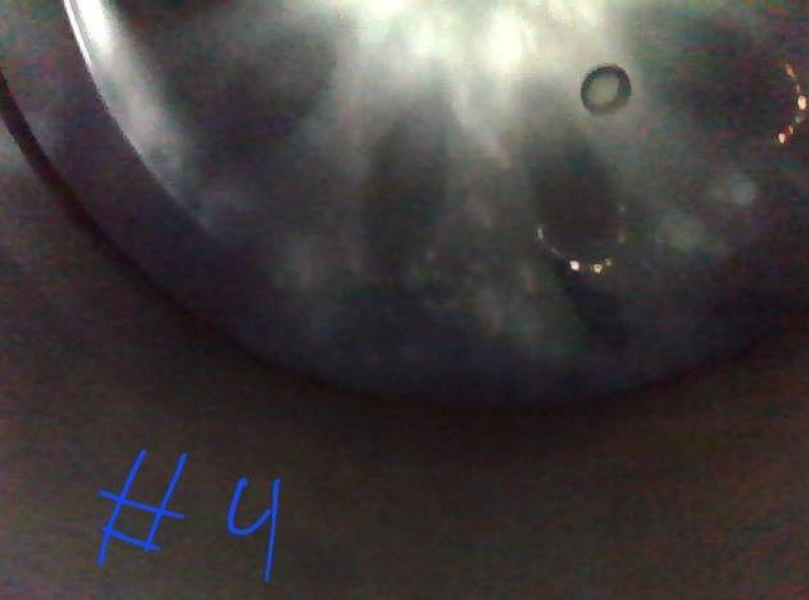
Below you can find pictures of the cylinder liners, valves, and piston heads, all showing to be in good condition. The crosshatching in the cylinder liners is in good condition, all valves look to be seated properly, and there are no markings or debris sitting on top of the pistons. There is some slight surface rust that is to be expected with an engine that has not been running. This will clear up without impacting the function or lifespan of the engine.

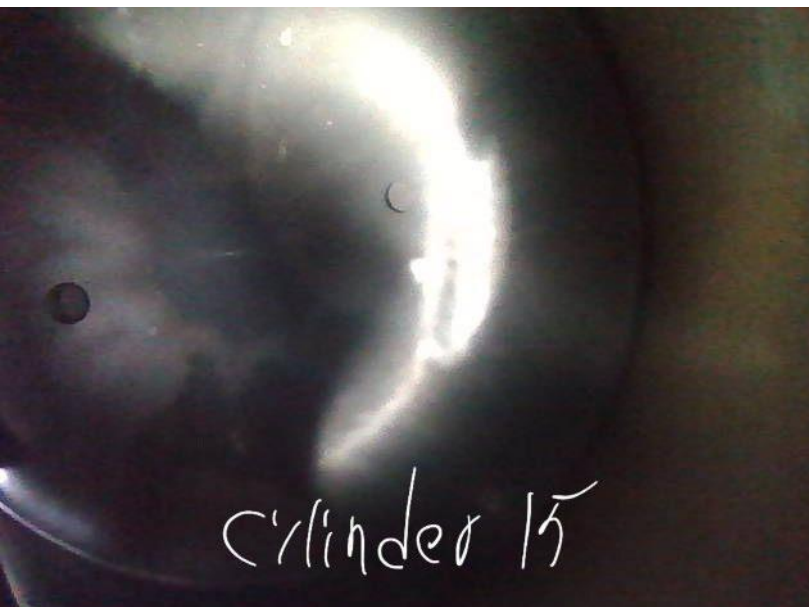
Cylinder 15

The pictures below were taken with a bore scope and show the condition of the top of the pistons, cylinder liners, and valves. All look to be in great condition with minimal surface rust. This engine was well preserved and looks to have a lot of life left in it.

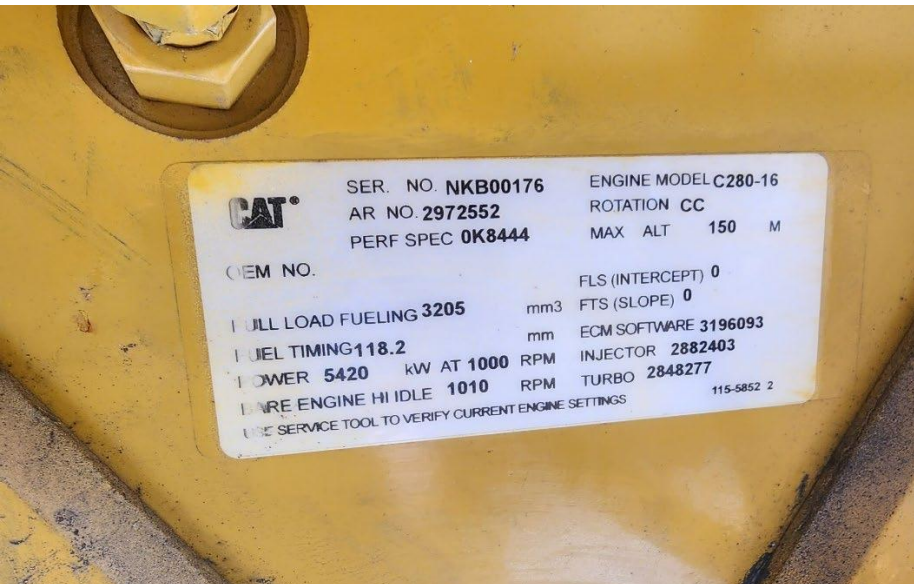
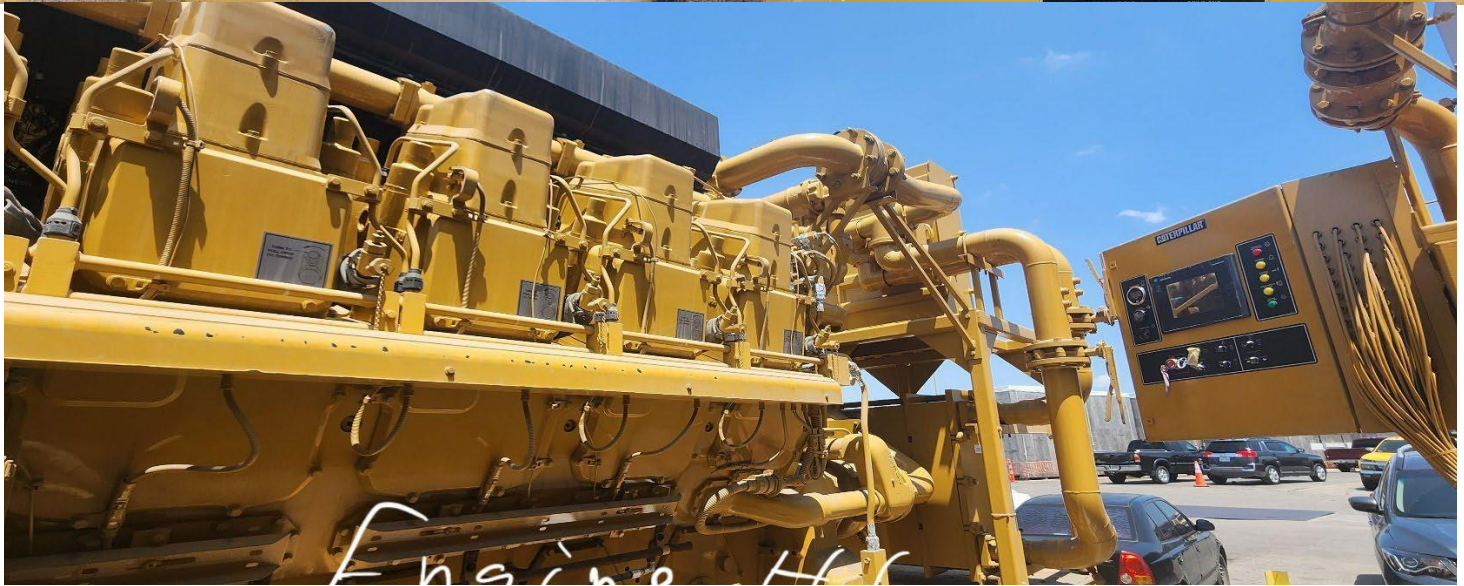
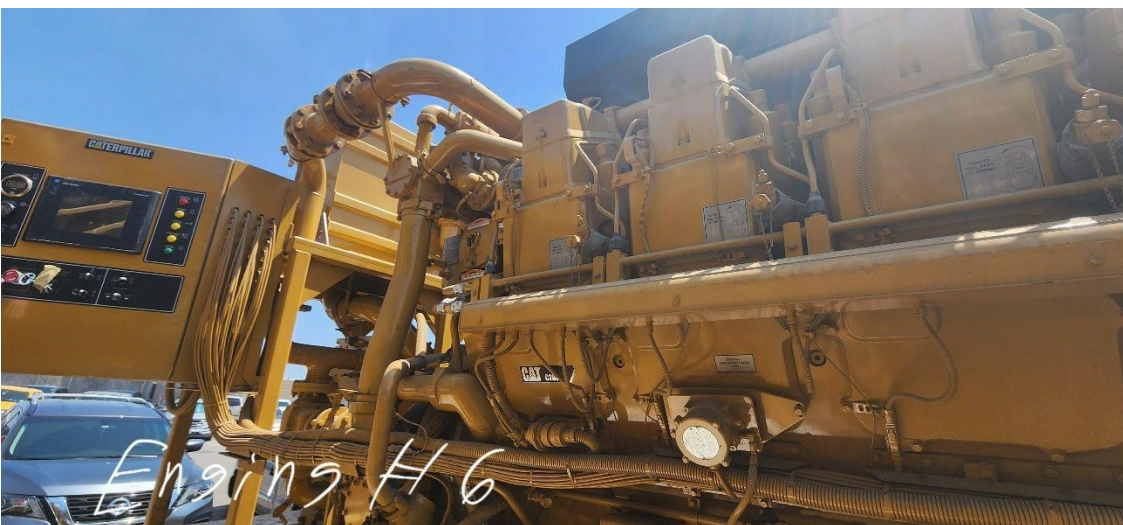
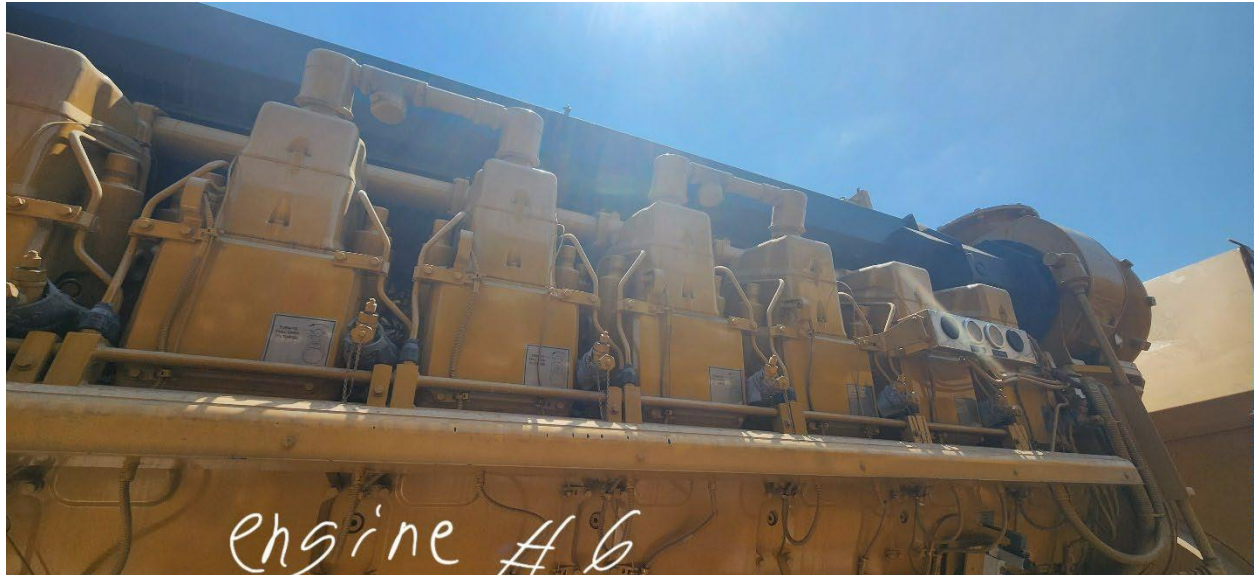
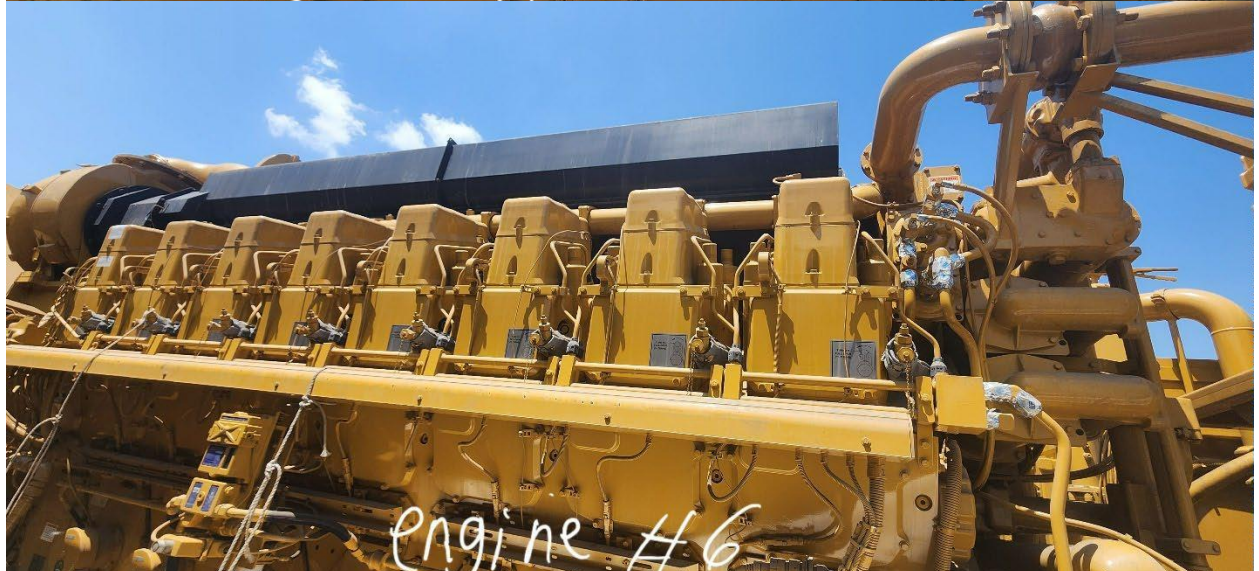
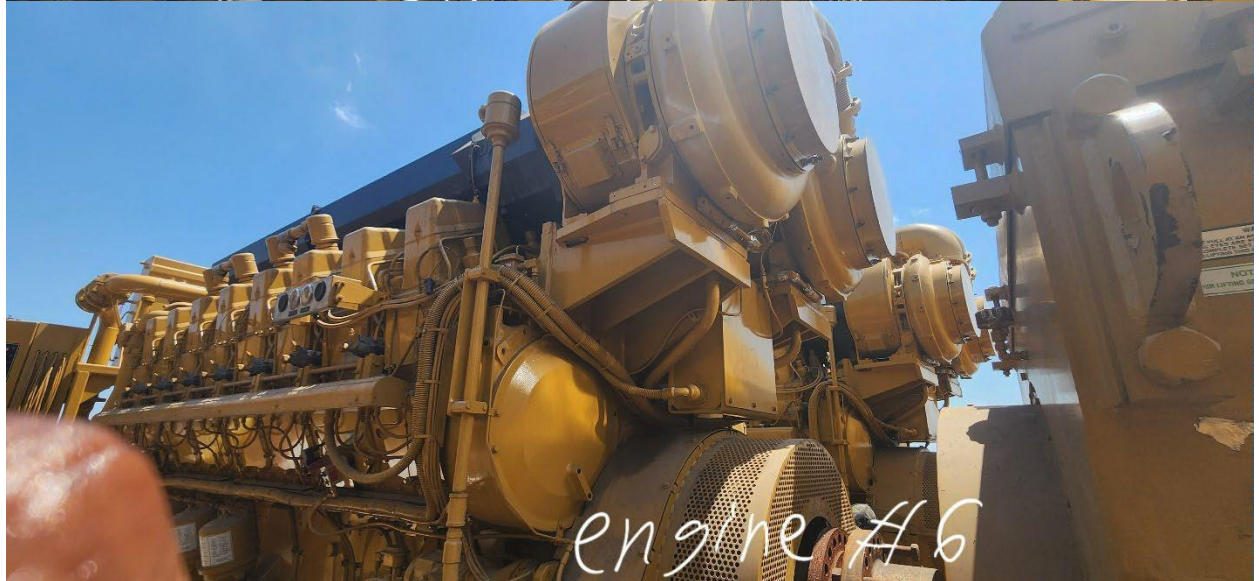
ROLLED THE ENGINE OVER AFTER CUTTING THE WRAPS OFF THE ENGINE. I ALSO DID A WALK AROUND AND CHECKED FOR ANY SIGNS OF LEAKS OR DAMAGE. NO SIGNS OF LEAKS WHILE DOING MY INSPECTIONS.EVERYTHING LOOKED TO BE IN GOOD CONDITION.

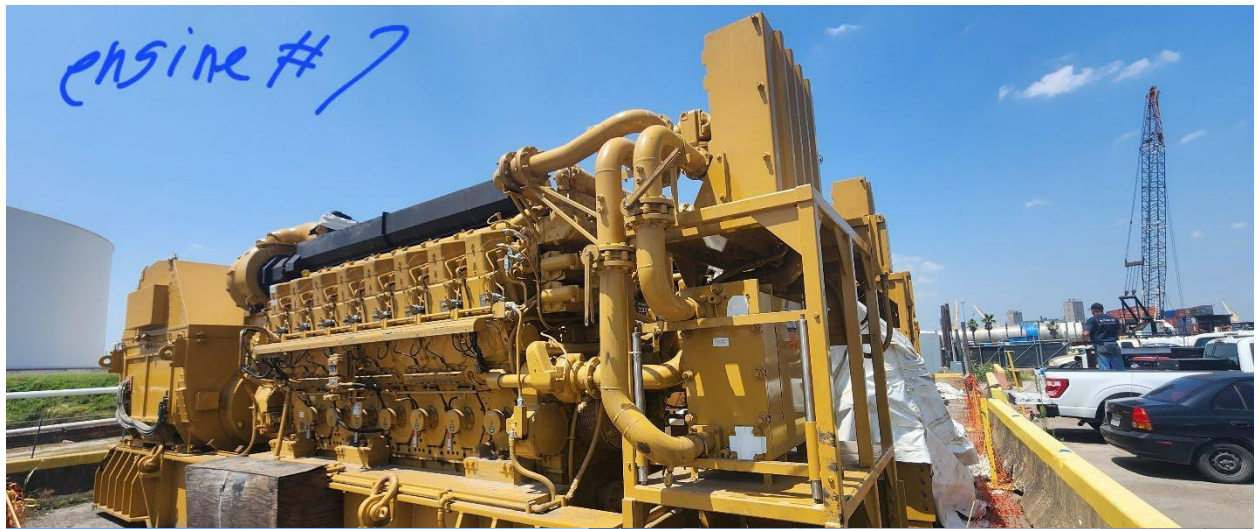
engine # 7

ROLLED THE ENGINE OVER AFTER CUTTING THE WRAPS OFF THE ENGINE. I ALSO DID A WALK AROUND AND CHECKED FOR ANY SIGNS OF LEAKS OR DAMAGE. NO SIGNS OF LEAKS WHILE DOING MY INSPECTIONS. EVERYTHING LOOKED TO BE IN GOOD CONDITION.

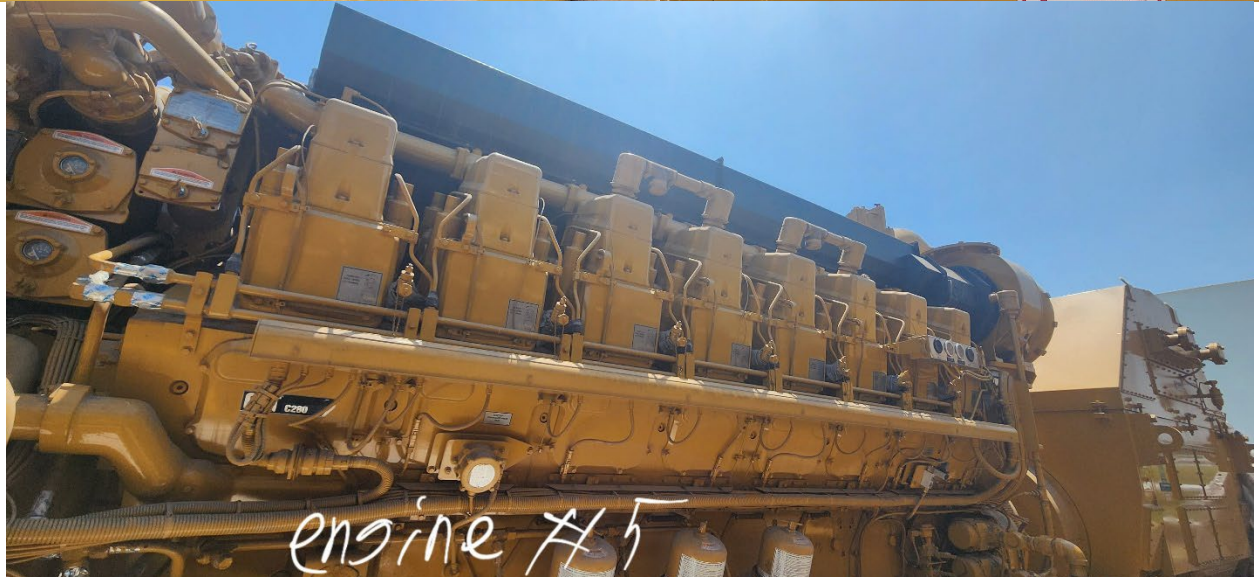
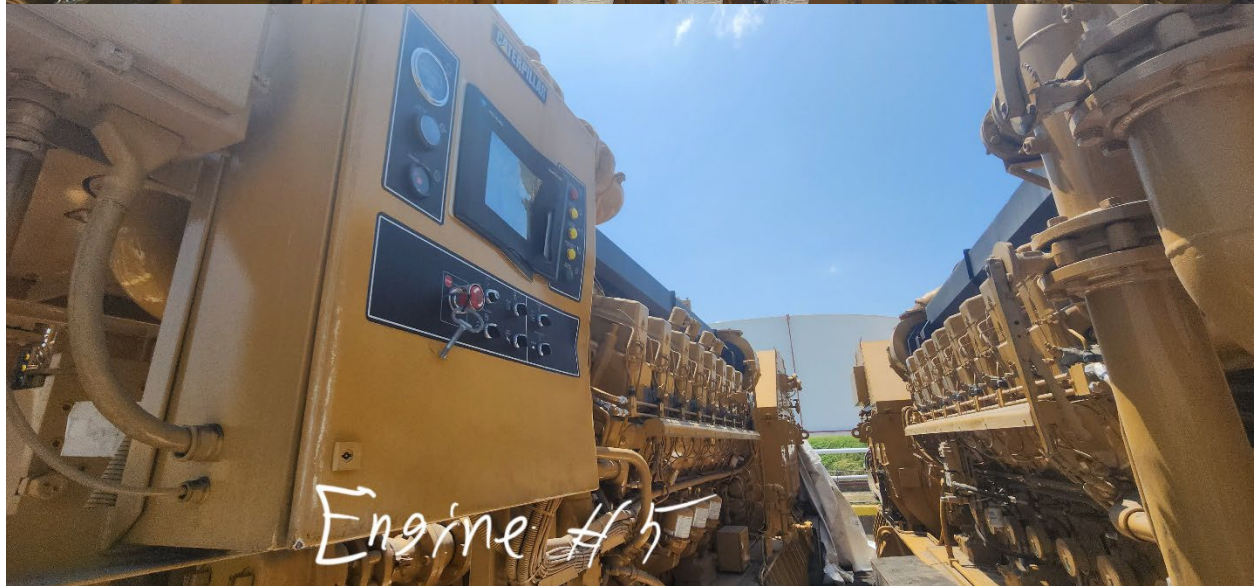
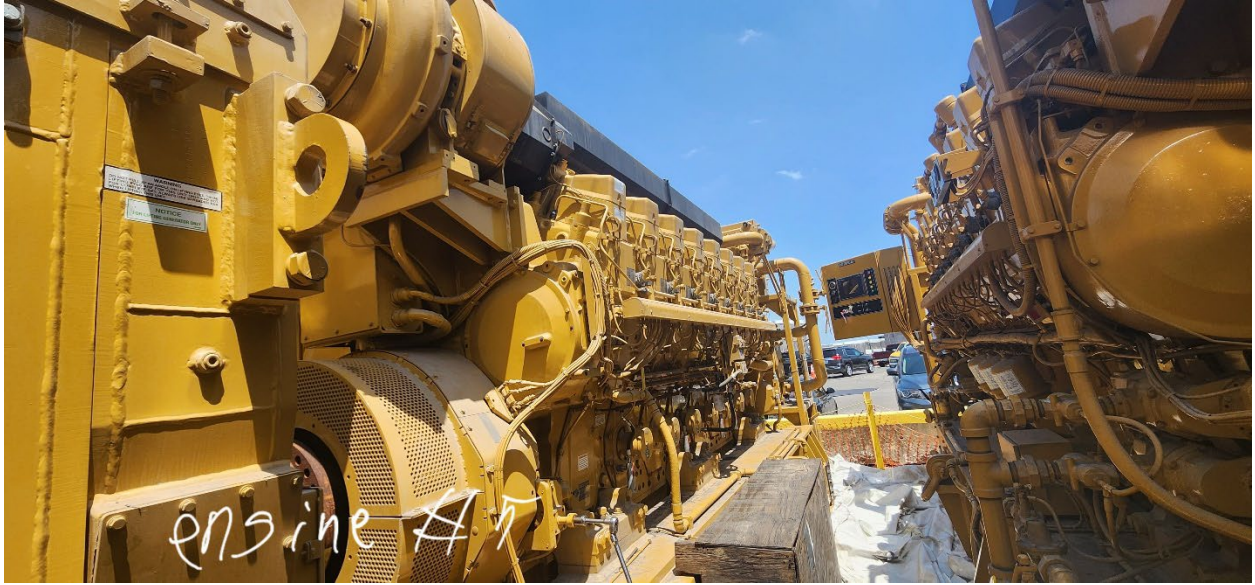
engine # 5

ROLLED THE ENGINE OVER AFTER CUTTING THE WRAPS OFF THE ENGINE. I ALSO DID A WALK AROUND AND CHECKED FOR ANY SIGNS OF LEAKS OR DAMAGE. NO SIGNS OF LEAKS WHILE DOING MY INSPECTIONS. EVERYTHING LOOKED TO BE IN GREAT CONDITION.
