Mustang Cat Marine Svc, LLC. 7001 Easthaven Blvd Houston, TX 77017 (713) 452-5250 mustangcat.com

Service Report Page ME02382 Customer Name: Harris Companies Marine Job #: Contact Person: Ray Lorenzo Technician: **DRAKE CHARLES** Contact Ph: (757) 342-3960 **Engine Hours:** Work Location: MANCHESTER TERMINAL Service Call Details 7 ENGINES WITH AN INSPECTION ON 3 OF THEM Model: C280 Problem Type: INSPECTIONS Equipment: Generator Call Type: O Port Equip/Vessel: Serial No.: NKB00178

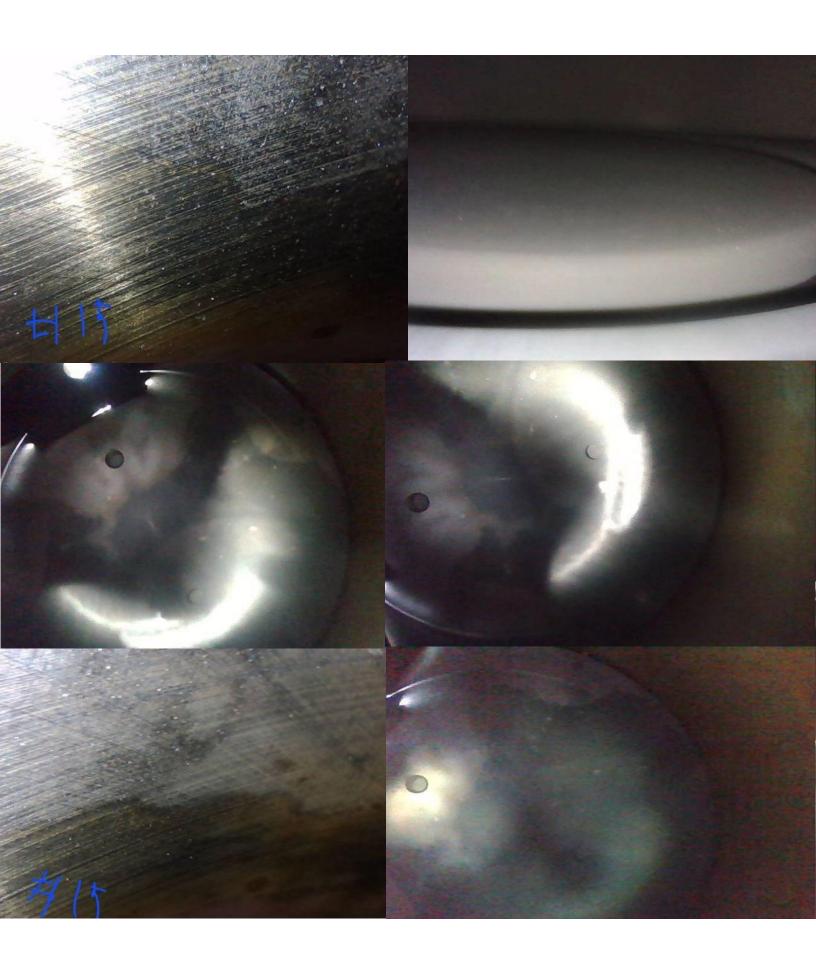
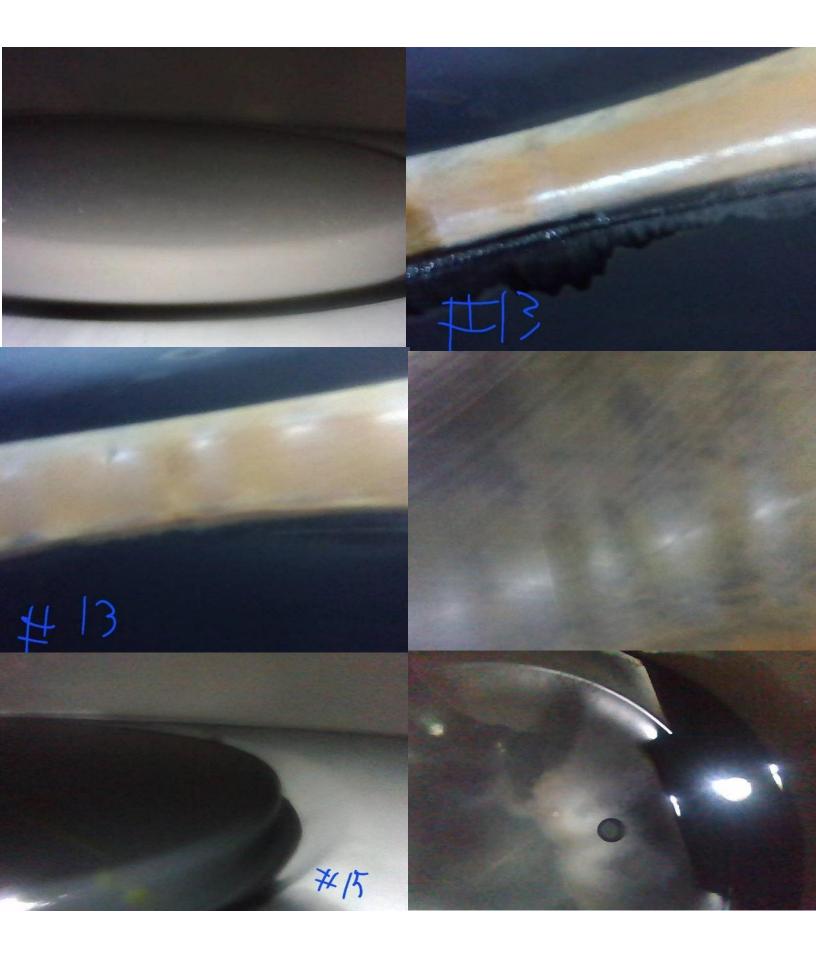
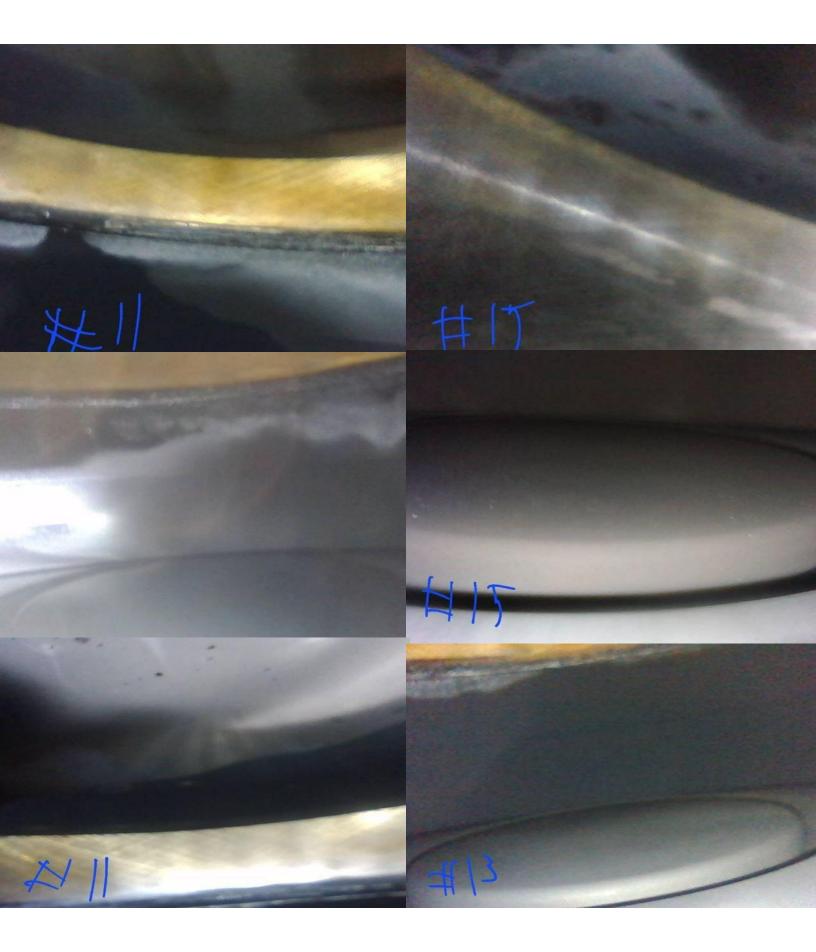
<u>e Report</u>	Page1of1
Customer Name: Harris	•		02382
Contact Person: Ray Lor			AKE CHARLES
Contact Ph: (757) 342 39	960	Engine Hours:	
Work Location:	MANCHESTER TERMINAL		
Service Call Details	7 ENGINES WITH AN INSPECTION ON 3 OF THE	M	
Model: C280		Problem Type: INS	PECTIONS
Equipment: Generator		Call Type:	
Equip/Vessel:		Serial No.: O Port	NIK BUUT SU
9	Subject:		
CYLINDERS 15,13,11 A CYLINDERS. ALL THE L GOES FOR THE PISTO ROLLED OVER JUST FOR	E COVERS AND LOOKED AT ALL THE ROCKE AND 7. WE PULLED THE ROCKER ARMS AN INNERS STILL HAD THEIR CROSS HATCHING NS. OVERALL HEALTH OF THIS ENGINE IS GIVE. Sectures showing the cylinder liners, valves, cylinder liners is in good condition, all valves.	D THEN PULLED THE INJECTORS WITH NO SIGNS OF WASH OUT GREAT. ENGINE DOES NOT SEEM and piston heads, all showing to	OUT THEN SCOPED THE OR ANY OTHER DAMAGE. SAME TO HAVE ANY LEAKS AND IT o be in great condition. The

debris sitting on top of	of the pistons.		
		6/26/2023	Drake Charles
Authorized Customer Repres	sentative (Print)	Date	Technician

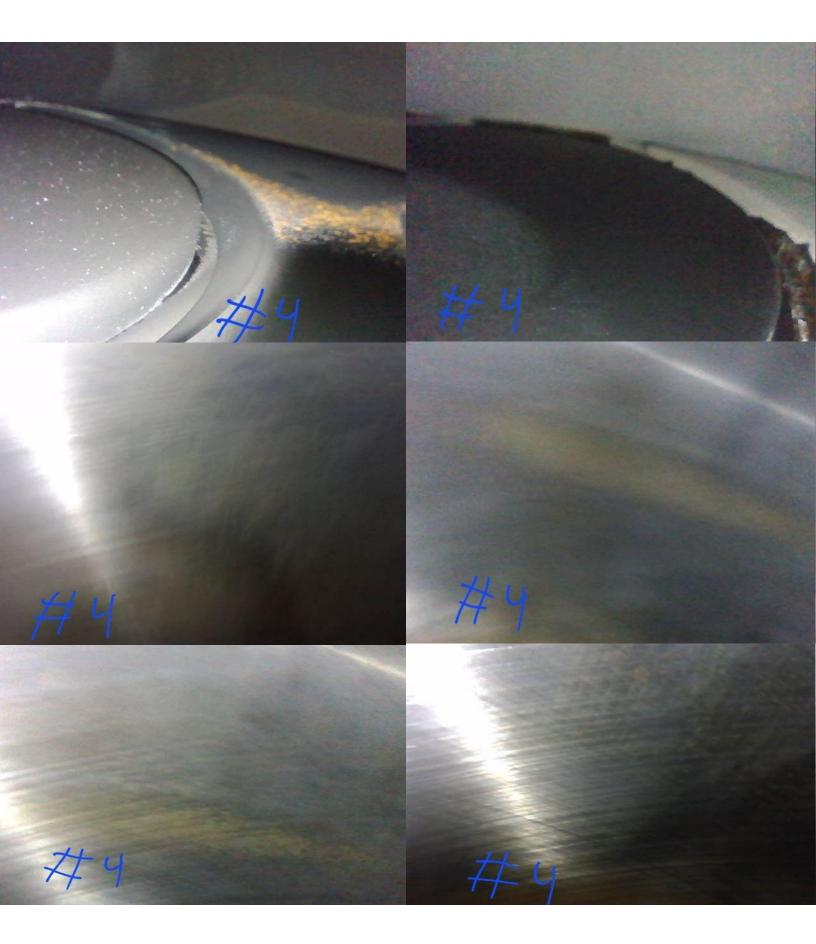
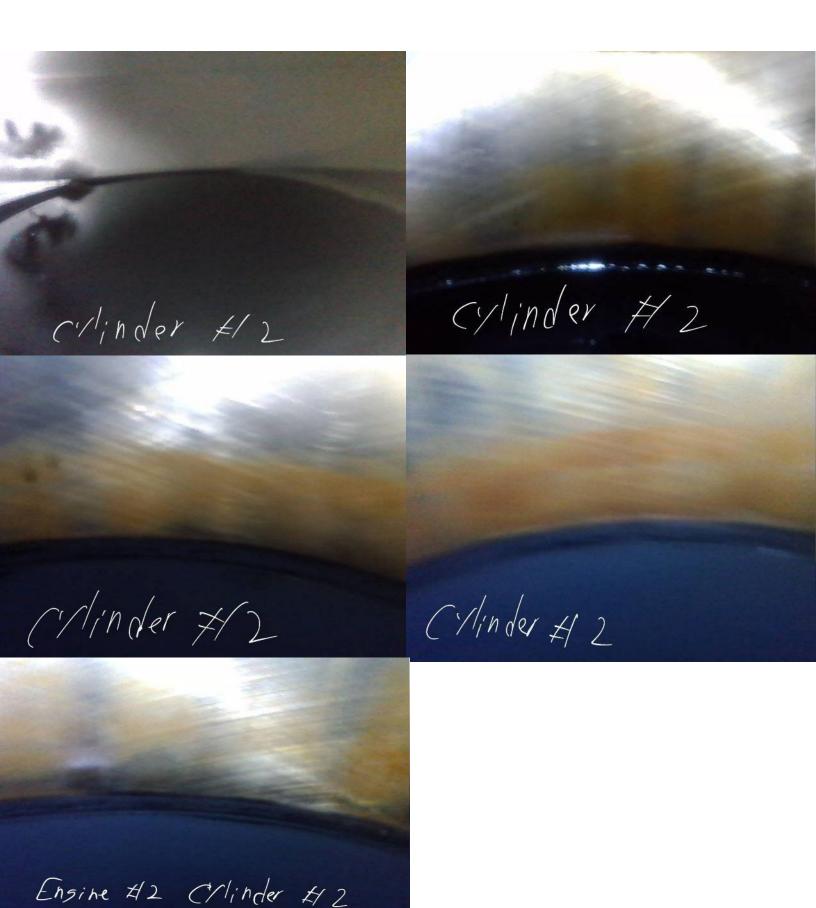
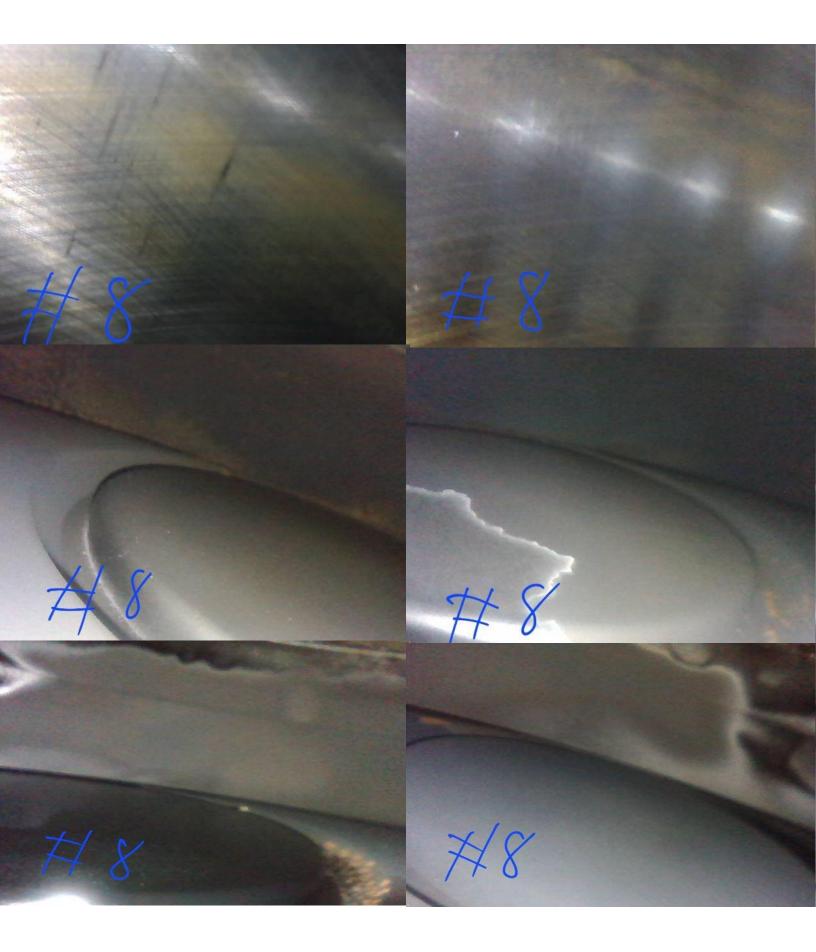
Cylinder #2 CYlinder # 2 Cylinder #12 Chinder #12 Chinder # 2

mustangcat.co
Service Report		Page	e <u>1</u>	of 1
· ·	arine Job #:	ME02382		
Contact Person: Ray Lorenzo Teo	chnician:	DRAKE CHA	ARLES	
Contact Ph: (757) 342 3960 En	gine Hours:			
Work Location: MANCHESTER TERMINAL				
Service Call Details 7 ENGINES WITH AN INSPECTION ON 3 OF THEM				
Model: C280 Pro	oblem Type:	INSPECTIO	NS	
Equipment: Generator Cal	ıll Type:			
Equip/Vessel: Ser	rial No.:	o Port o Starboard	NKB00177	
Subject:				
Service Details REMOVED THE VALVE COVERS AND LOOKED AT ALL THE VALVE TRAIN. NEXT WE THE ROCKER ARMS AND THEN PULLED THE INJECTORS OUT THEN SCOPED THE CYCROSS HATCHING WITH NO SIGNS OF WASH OUT OR ANY OTHER DAMAGE. SAM OF THIS ENGINE IS GREAT. ENGINE DOES NOT SEEM TO HAVE ANY LEAKS AND IT HAVE A LITTLE BIT OF SURFACE RUST ON THE BOTTOM OF THE HEAD AND ALSO TO BE ALARMED ABOUT. THATS NORMAL FOR HOW LONG THESE ENGINE'S HAVING BEIOW you can find pictures of the cylinder liners, valves, and piston heads, all sh crosshatching in the cylinder liners is in good condition, all valves look to be seat debris sitting on top of the pistons. There is some slight surface rust that is to be running. This will clear up without impacting the function or lifespan of the engire and the engine of the cylinder liners is a some slight surface. Authorized Customer Representative (Print)	YLINDERS. IE GOES FO ROLLED O ON THE LI TE BEEN SIT Howing to led proper Expected The expected T	ALL THE LINDER THE PISTONER JUST FILE NERS THEM ITING. The in good color of the pilone in good color of the pilone in good color of the pilone in good the pilone	NERS STILL HONS. OVERANE. CYLINDE SELVES, BU Condition. The	AD THEIR LL HEALTH RS 2,4 AND F NOTHING e kings or not been

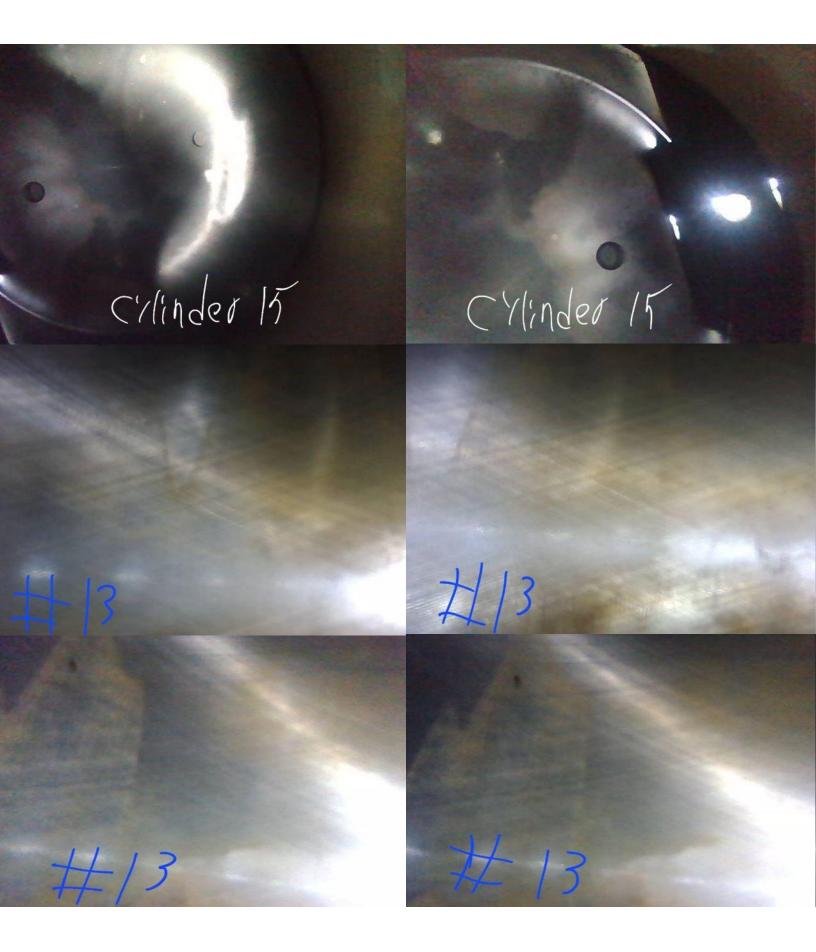
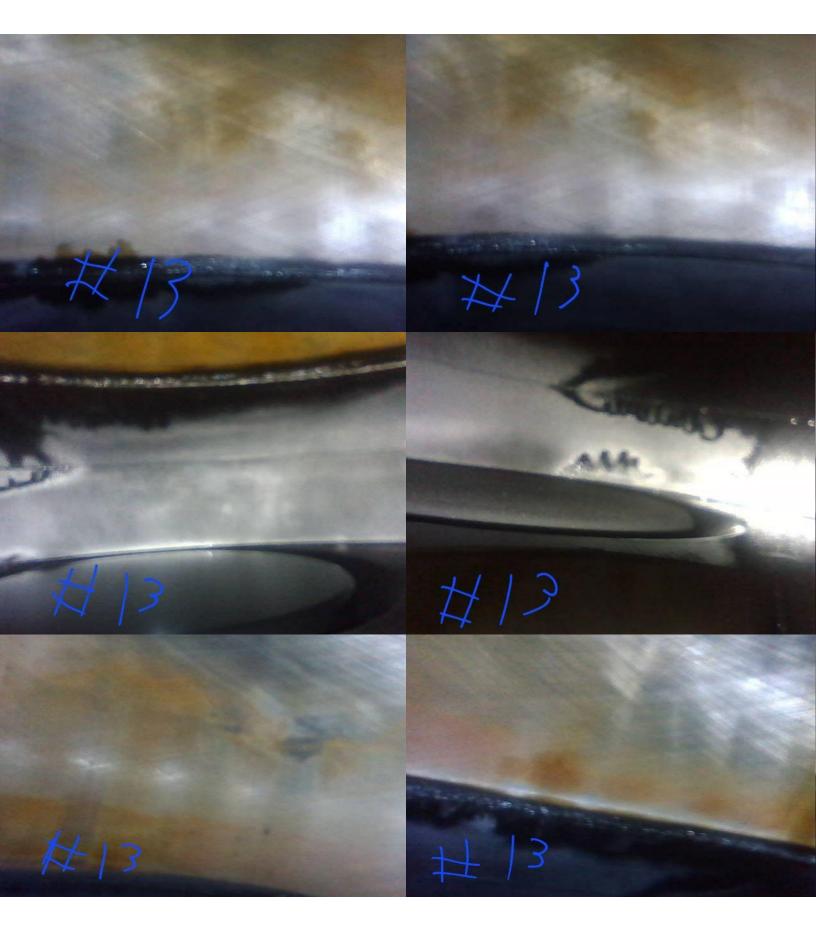
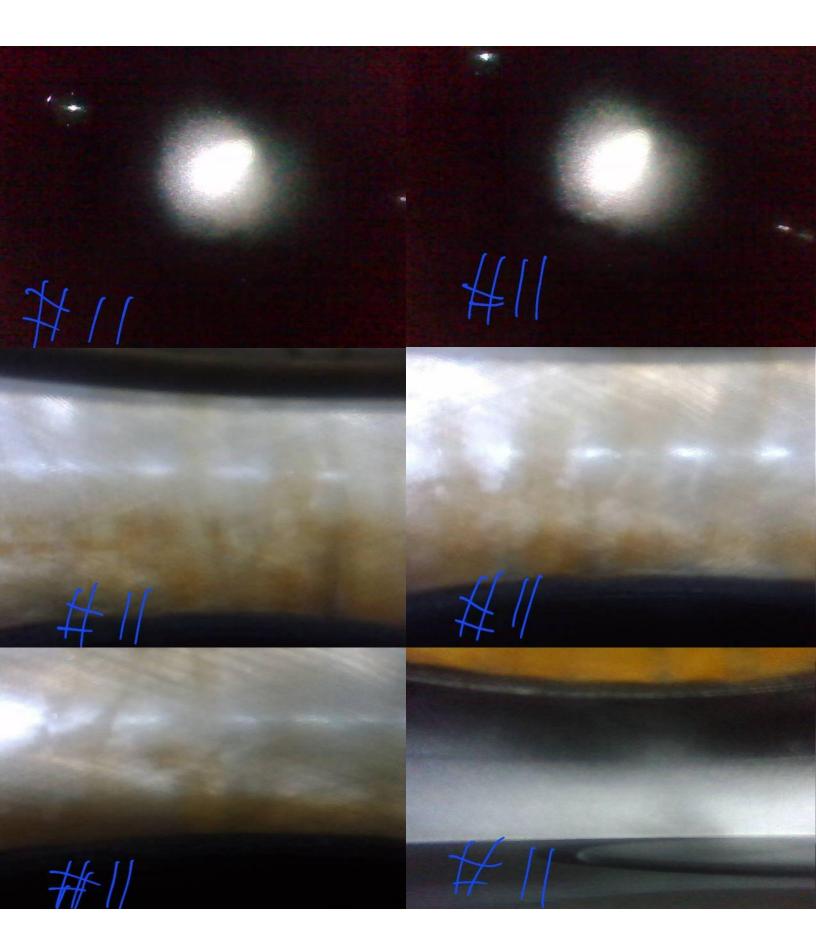
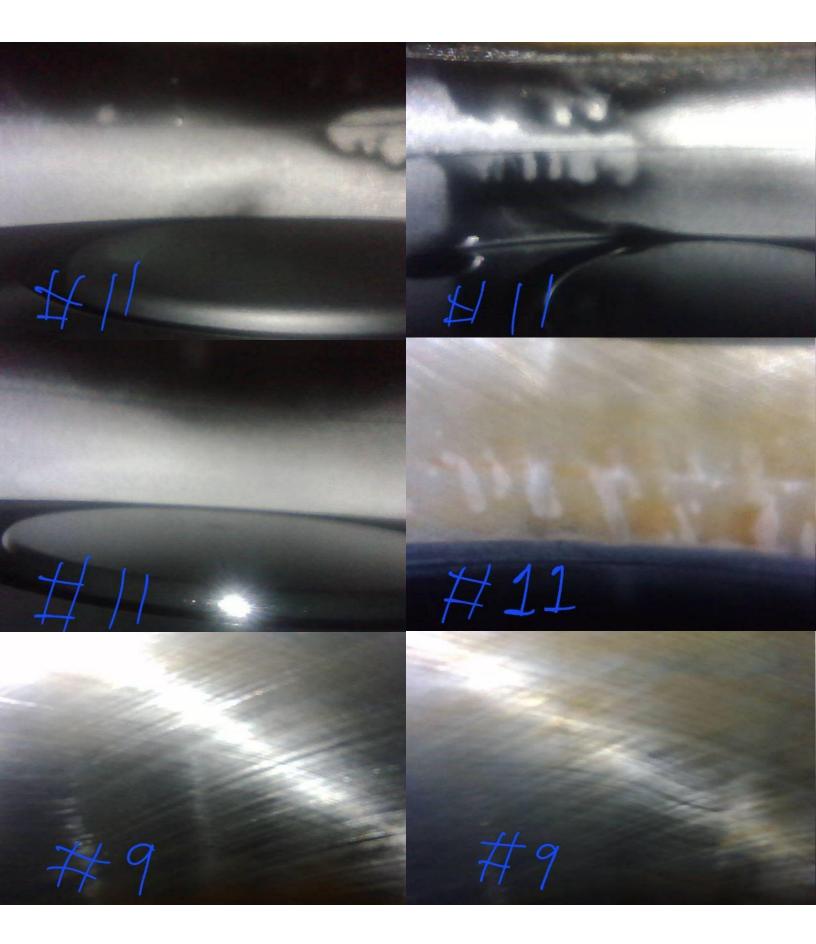
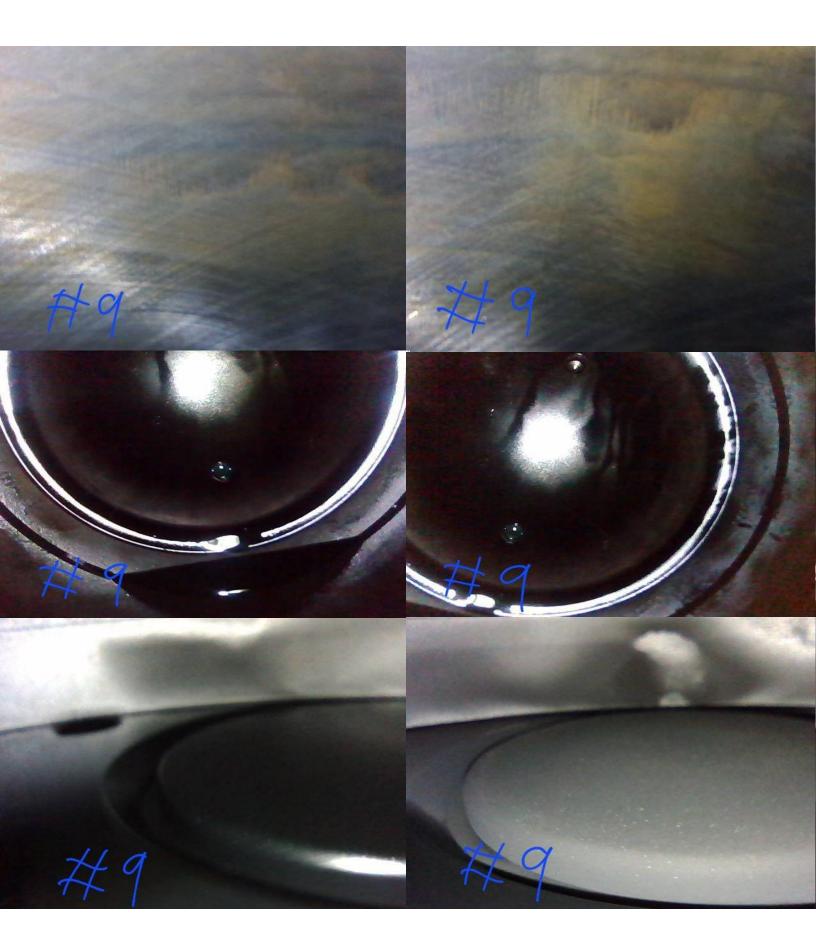
Chinder #19 #15 Cylinder 15 # 15 Cylinder 15 Minder 15

mustangcat.com Service Report Page ME02382 Customer Name: Harris Companies Marine Job #: Contact Person: Ray Lorenzo **DRAKE CHARLES** Technician: Contact Ph: (757) 342 3960 **Engine Hours:** Work Location: MANCHESTER TERMINAL 7 ENGINES WITH AN INSPECTION ON 3 OF THEM Service Call Details Model: C280 Problem Type: INSPECTIONS Equipment: Generator Call Type: O Port Equip/Vessel: Serial No.: NKB00174 Subject: **Service Details** REMOVED THE VALVE COVERS AND LOOKED AT ALL THE VALVE TRAIN. NEXT WE SCOPED CYLINDERS 15,13,11 AND 9. WE PULLED THE ROCKER ARMS AND THEN PULLED THE INJECTORS OUT THEN SCOPED THE CYLINDERS. ALL THE LINERS STILL HAD THEIR CROSS HATCHING WITH NO SIGNS OF WASH OUT OR ANY OTHER DAMAGE. SAME GOES FOR THE PISTONS. OVERALL HEALTH OF THIS ENGINE IS GREAT. THESE CYLINDERS WERE THE BEST OUT OF THE BUNCH. NOT ONE SINGLE PROBLEM FROM THIS UNIT. AFTER PUTTING EVERYTHING BACK TOGETHER WE ROLLED THE ENGINE OVER WITHOUT ANY PROBLEM. The pictures below were taken with a bore scope and show the condition of the top of the pistons, cylinder liners, and valves. All look to be in great condition with minimal surface rust. This engine was well preserved and looks to have a lot of life left in it. 6/26/2023 **Drake Charles** Date Technician Authorized Customer Representative (Print)
