Service Report

Customer Name: Harris Companies	Marine Job #: ME02382
Contact Person: Ray Lorenzo	Technician: DRAKE CHARLES
Contact Ph: (757) 342 3960	Engine Hours:
Work Location: MANCHESTER TERMINAL	
<u>Service Call Details</u> 7 ENGINES WITH AN INSPECTION ON 3 OF THEM	
Model: C280	Problem Type: INSPECTIONS
Equipment: Generator	Call Type:
Equip/Vessel:	Serial No.: o Port o Starboard NKB00180

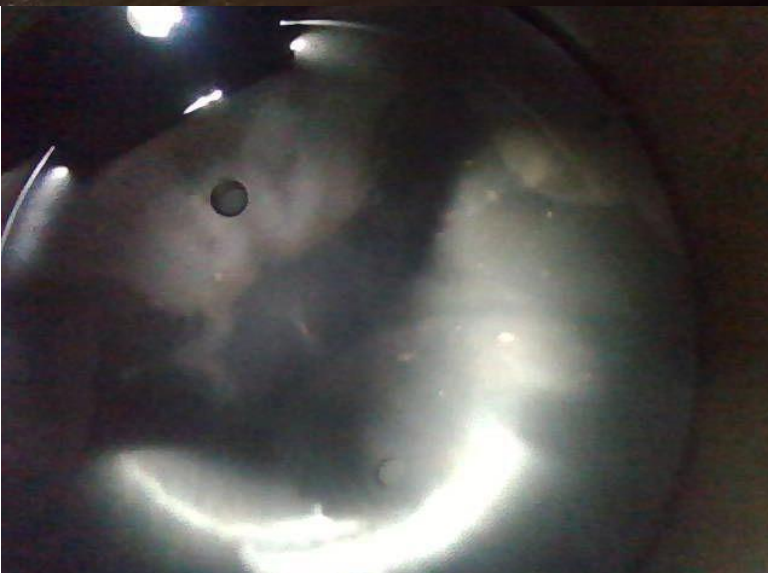
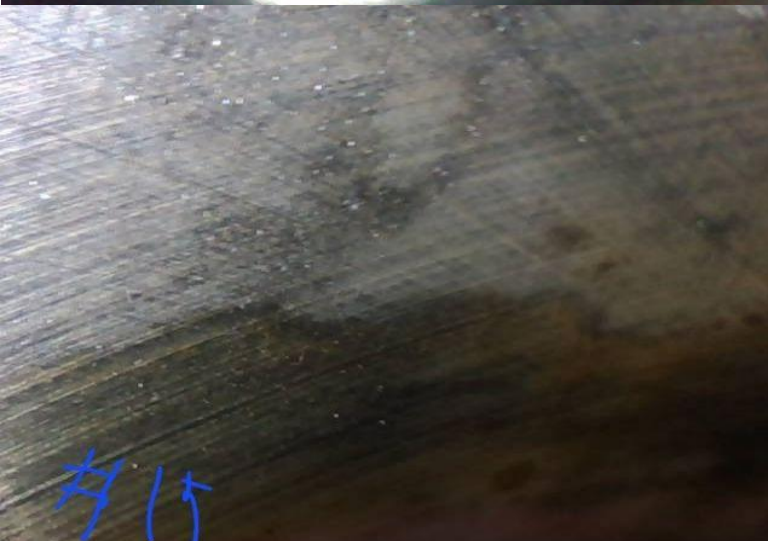
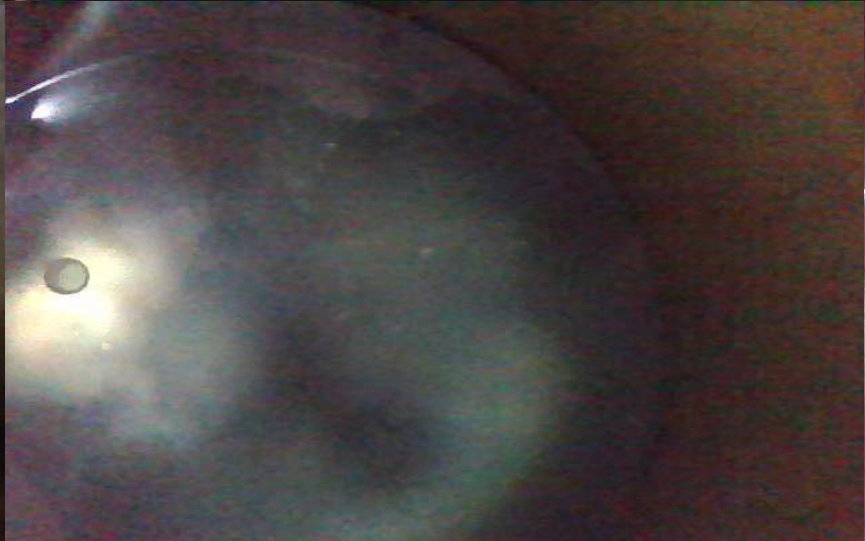
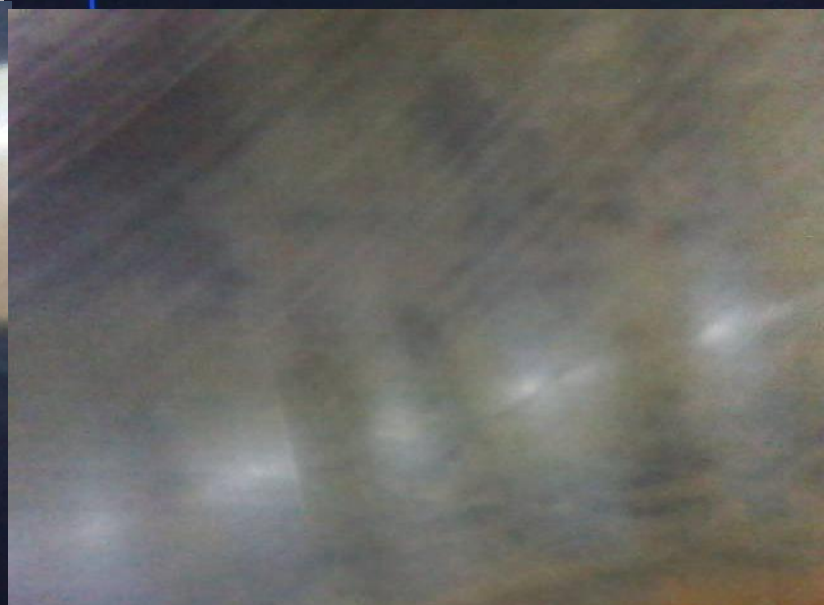
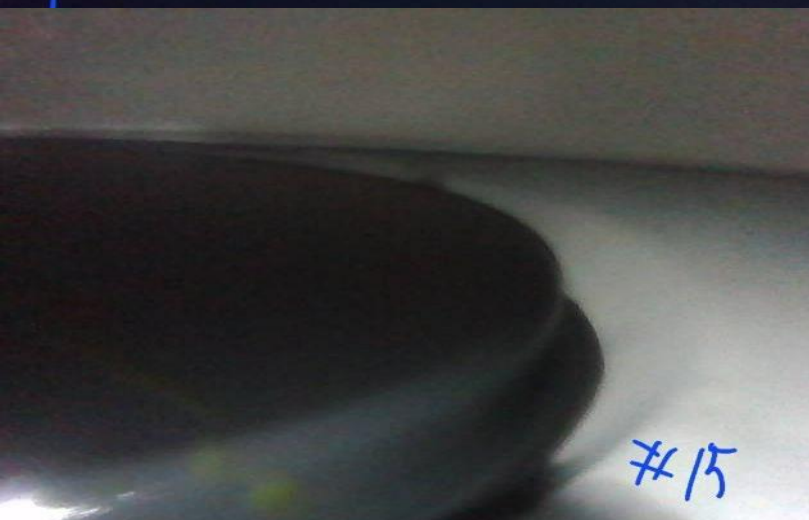
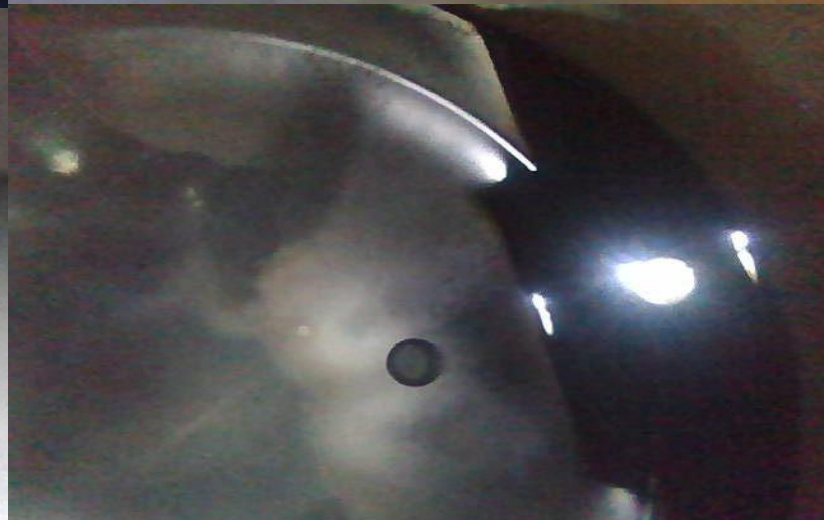
REMOVED THE VALVE COVERS AND LOOKED AT ALL THE ROCKER ARMS,PUSH RODS AND EVERYTHING ELSE. NEXT WE SCOPED CYLINDERS 15,13,11 AND 7. WE PULLED THE ROCKER ARMS AND THEN PULLED THE INJECTORS OUT THEN SCOPED THE CYLINDERS. ALL THE LINERS STILL HAD THEIR CROSS HATCHING WITH NO SIGNS OF WASH OUT OR ANY OTHER DAMAGE. SAME GOES FOR THE PISTONS. OVERALL HEALTH OF THIS ENGINE IS GREAT. ENGINE DOES NOT SEEM TO HAVE ANY LEAKS AND IT ROLLED OVER JUST FINE.

Below you can find pictures showing the cylinder liners, valves, and piston heads, all showing to be in great condition. The crosshatching in the cylinder liners is in good condition, all valves look to be seated properly, and there are no markings or debris sitting on top of the pistons.

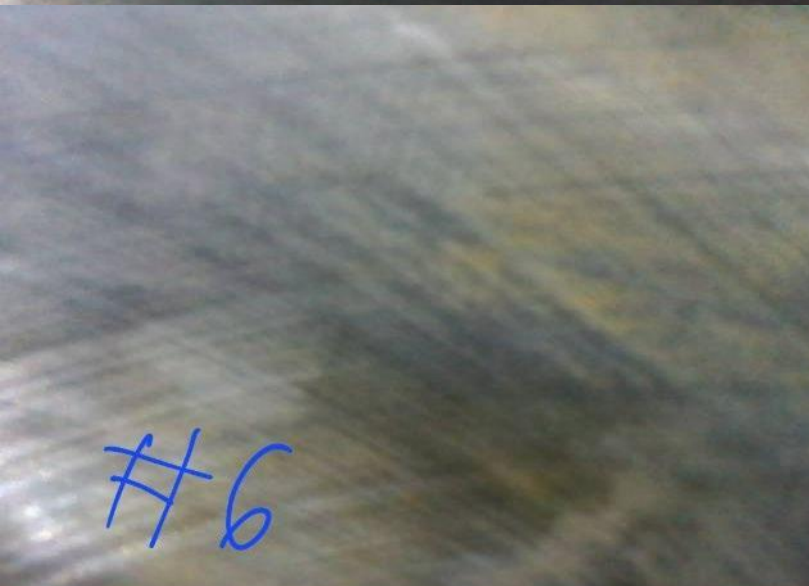
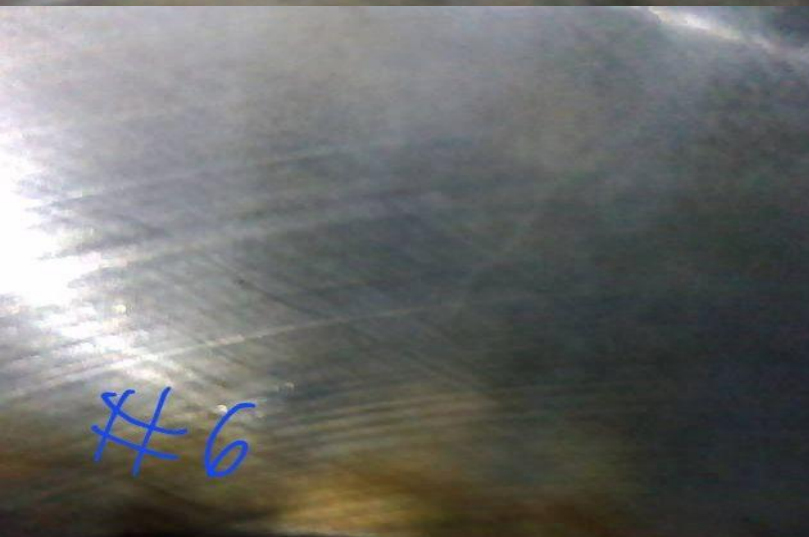
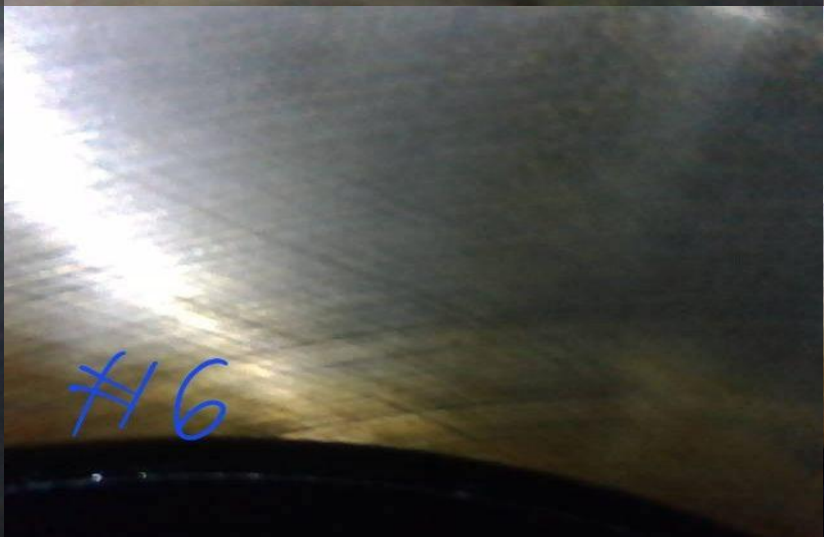
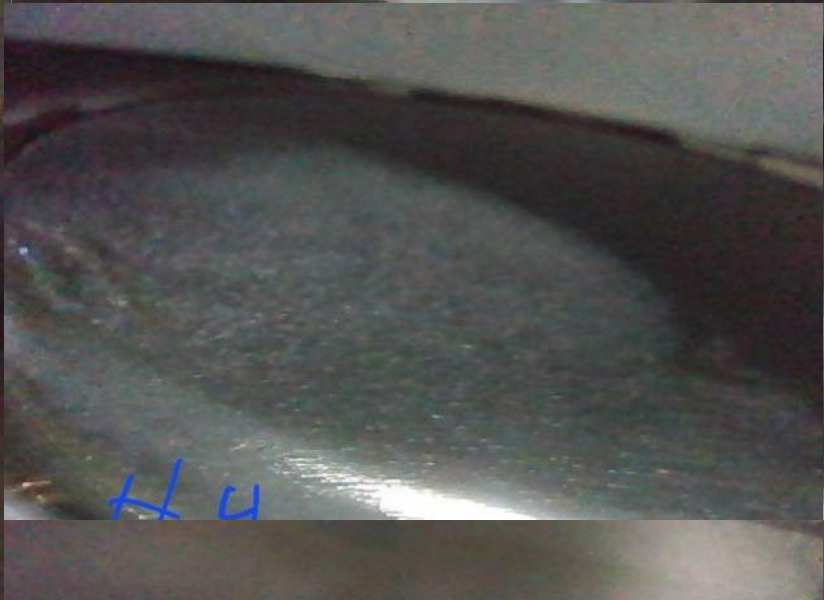
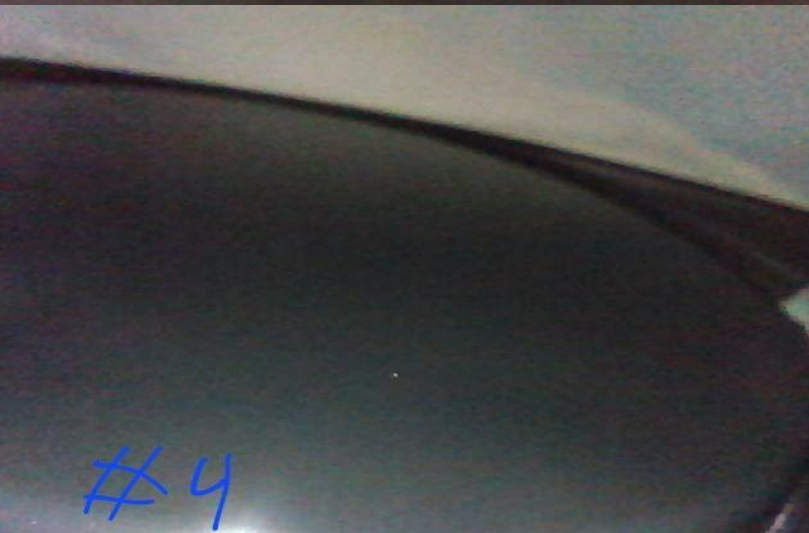
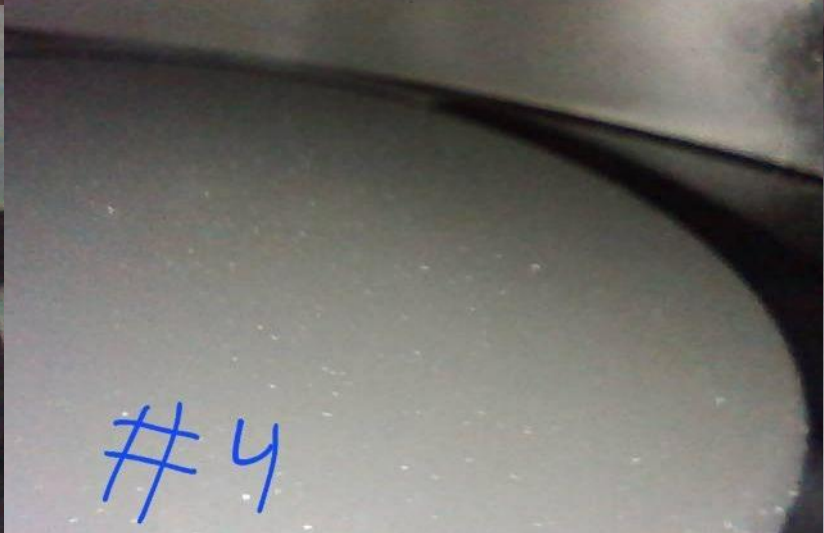
REMOVED THE VALVE COVERS AND LOOKED AT ALL THE VALVE TRAIN. NEXT WE SCOPED CYLINDERS 2,4,6 AND 8. WE PULLED THE ROCKER ARMS AND THEN PULLED THE INJECTORS OUT THEN SCOPED THE CYLINDERS. ALL THE LINERS STILL HAD THEIR CROSS HATCHING WITH NO SIGNS OF WASH OUT OR ANY OTHER DAMAGE. SAME GOES FOR THE PISTONS. OVERALL HEALTH OF THIS ENGINE IS GREAT. ENGINE DOES NOT SEEM TO HAVE ANY LEAKS AND IT ROLLED OVER JUST FINE. CYLINDERS 2,4 AND 6 HAVE A LITTLE BIT OF SURFACE RUST ON THE BOTTOM OF THE HEAD AND ALSO ON THE LINERS THEM SELVES, BUT NOTHING TO BE ALARMED ABOUT. THATS NORMAL FOR HOW LONG THESE ENGINE'S HAVE BEEN SITTING.

Below you can find pictures of the cylinder liners, valves, and piston heads, all showing to be in good condition. The crosshatching in the cylinder liners is in good condition, all valves look to be seated properly, and there are no markings or debris sitting on top of the pistons. There is some slight surface rust that is to be expected with an engine that has not been running. This will clear up without impacting the function or lifespan of the engine.

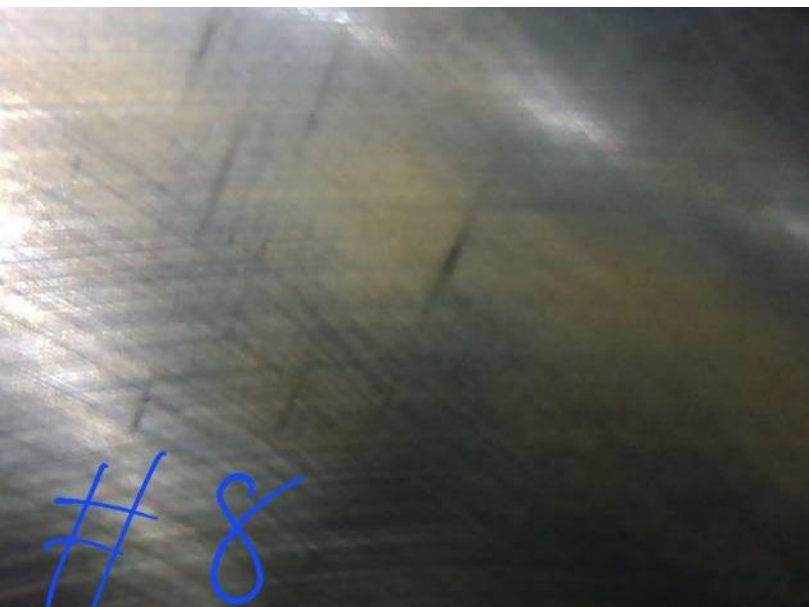
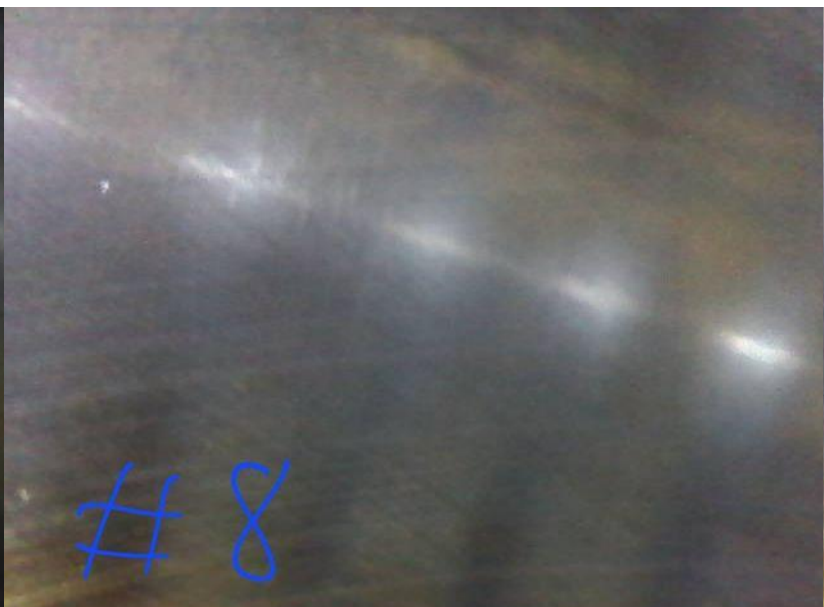
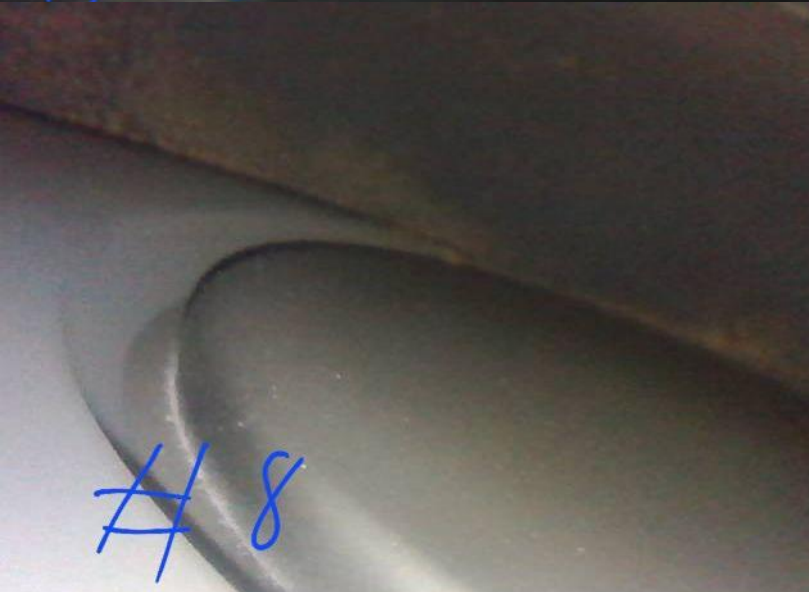
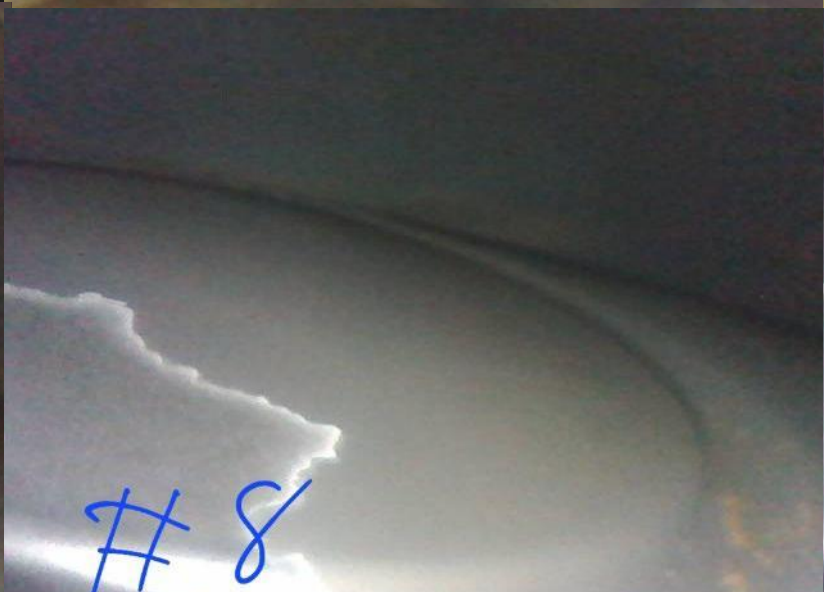
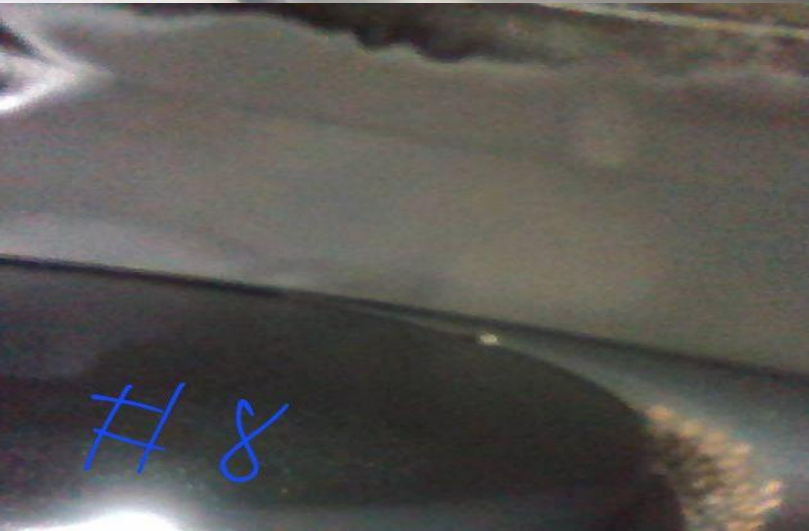
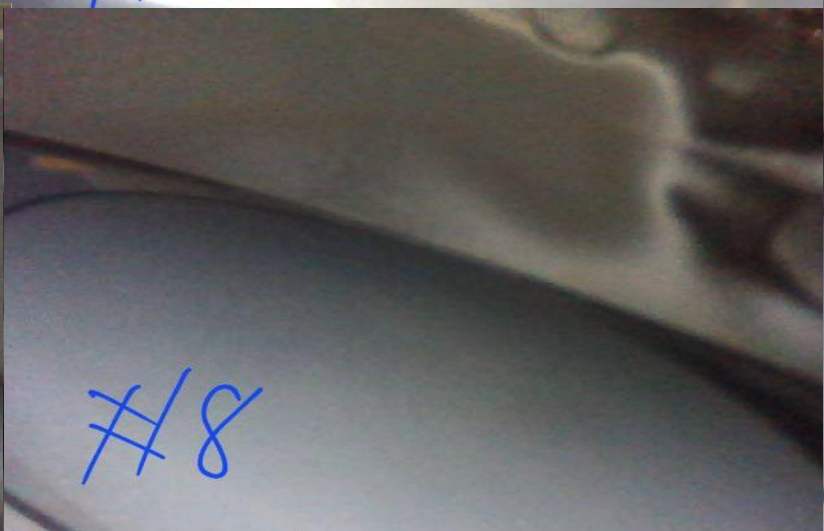
The pictures below were taken with a bore scope and show the condition of the top of the pistons, cylinder liners, and valves. All look to be in great condition with minimal surface rust. This engine was well preserved and looks to have a lot of life left in it.

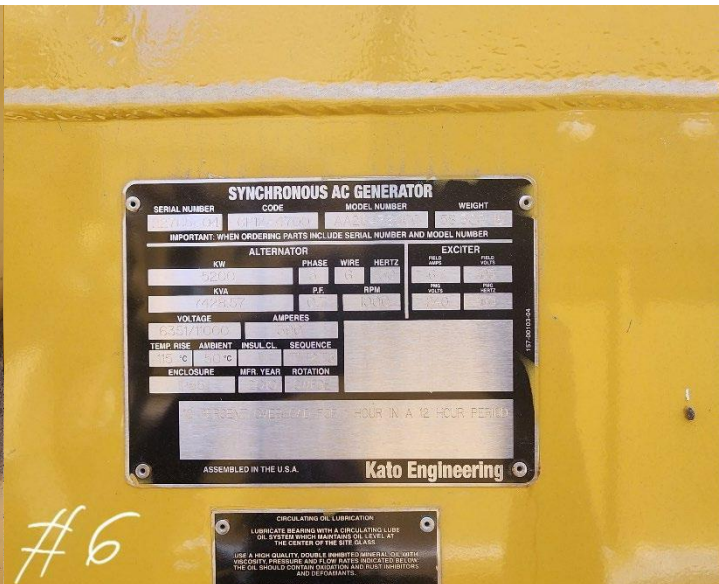
ROLLED THE ENGINE OVER AFTER CUTTING THE WRAPS OFF THE ENGINE. I ALSO DID A WALK AROUND AND CHECKED FOR ANY SIGNS OF LEAKS OR DAMAGE. NO SIGNS OF LEAKS WHILE DOING MY INSPECTIONS.EVERYTHING LOOKED TO BE IN GOOD CONDITION.

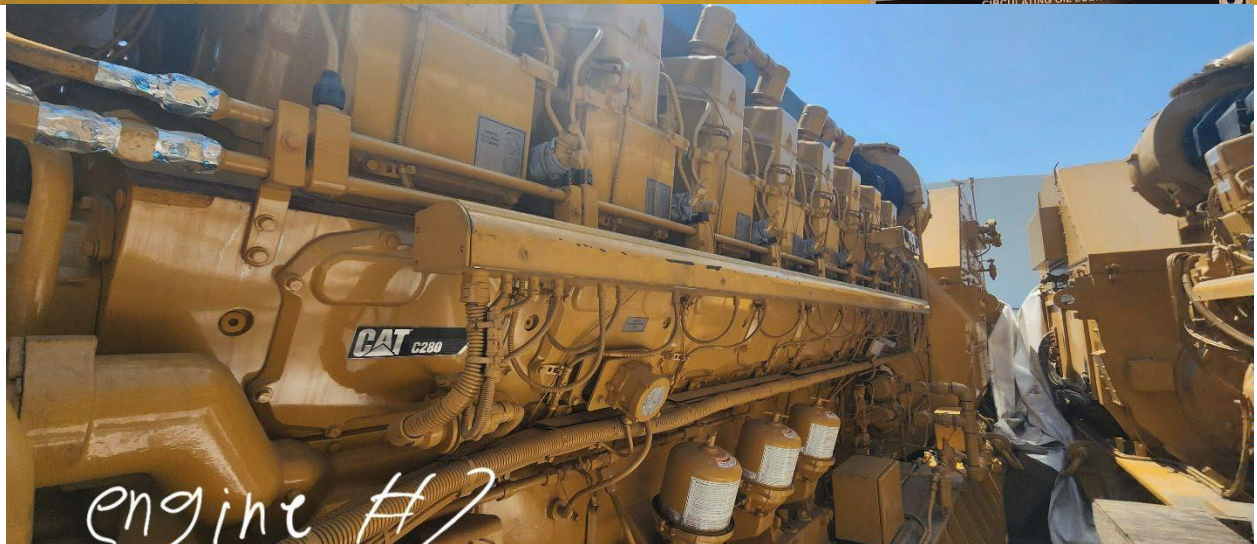
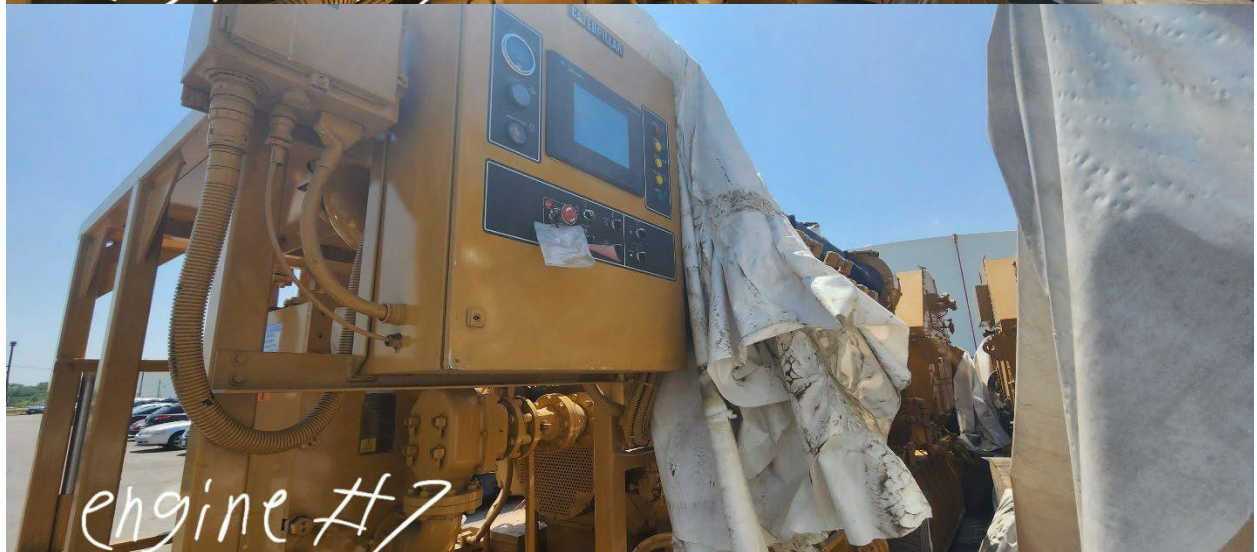
ROLLED THE ENGINE OVER AFTER CUTTING THE WRAPS OFF THE ENGINE. I ALSO DID A WALK AROUND AND CHECKED FOR ANY SIGNS OF LEAKS OR DAMAGE. NO SIGNS OF LEAKS WHILE DOING MY INSPECTIONS. EVERYTHING LOOKED TO BE IN GOOD CONDITION.

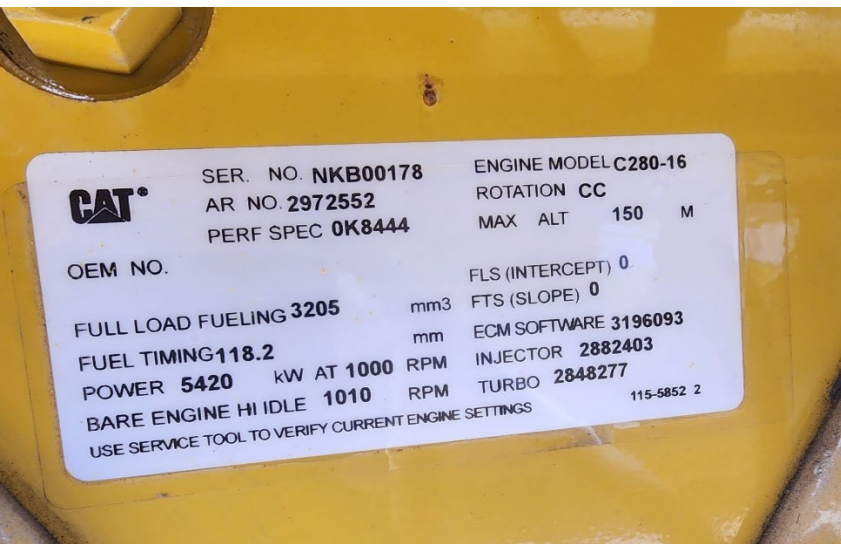
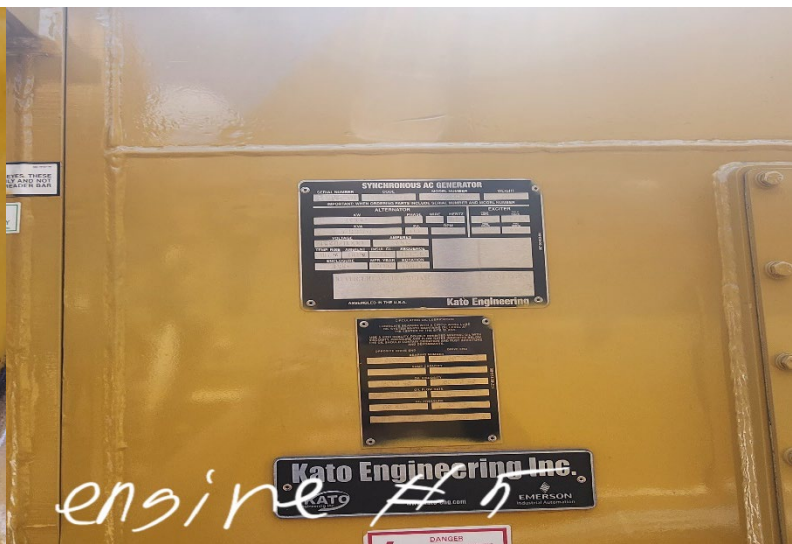
engine # 5

ROLLED THE ENGINE OVER AFTER CUTTING THE WRAPS OFF THE ENGINE. I ALSO DID A WALK AROUND AND CHECKED FOR ANY SIGNS OF LEAKS OR DAMAGE. NO SIGNS OF LEAKS WHILE DOING MY INSPECTIONS. EVERYTHING LOOKED TO BE IN GREAT CONDITION.
