Mustang Cat Marine Svc, LLC. 7001 Easthaven Blvd Houston, TX 77017 (713) 452-5250 mustangcat.com

Service Report Page ME02382 Customer Name: Harris Companies Marine Job #: Contact Person: Ray Lorenzo Technician: **DRAKE CHARLES** Contact Ph: (757) 342-3960 **Engine Hours:** Work Location: MANCHESTER TERMINAL Service Call Details 7 ENGINES WITH AN INSPECTION ON 3 OF THEM Model: C280 Problem Type: INSPECTIONS Equipment: Generator Call Type: O Port Equip/Vessel: Serial No.: NKB00178

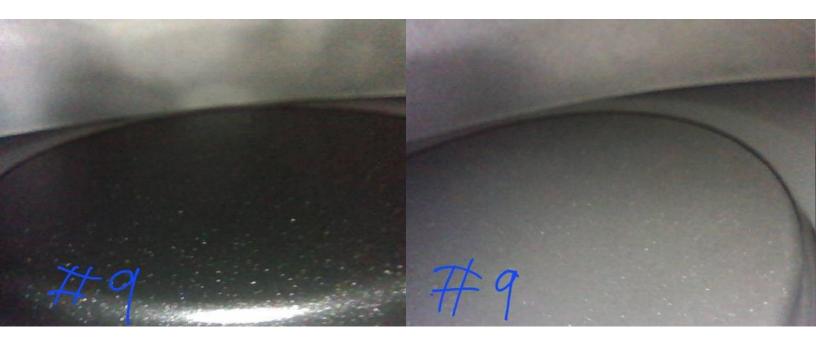
Chinder #19 #15 Cylinder 15 # 15 Cylinder 15 Minder 15

mustangcat.com Service Report Page ME02382 Customer Name: Harris Companies Marine Job #: Contact Person: Ray Lorenzo **DRAKE CHARLES** Technician: Contact Ph: (757) 342 3960 **Engine Hours:** Work Location: MANCHESTER TERMINAL 7 ENGINES WITH AN INSPECTION ON 3 OF THEM Service Call Details Model: C280 Problem Type: INSPECTIONS Equipment: Generator Call Type: O Port Equip/Vessel: Serial No.: NKB00174 Subject: **Service Details** REMOVED THE VALVE COVERS AND LOOKED AT ALL THE VALVE TRAIN. NEXT WE SCOPED CYLINDERS 15,13,11 AND 9. WE PULLED THE ROCKER ARMS AND THEN PULLED THE INJECTORS OUT THEN SCOPED THE CYLINDERS. ALL THE LINERS STILL HAD THEIR CROSS HATCHING WITH NO SIGNS OF WASH OUT OR ANY OTHER DAMAGE. SAME GOES FOR THE PISTONS. OVERALL HEALTH OF THIS ENGINE IS GREAT. THESE CYLINDERS WERE THE BEST OUT OF THE BUNCH. NOT ONE SINGLE PROBLEM FROM THIS UNIT. AFTER PUTTING EVERYTHING BACK TOGETHER WE ROLLED THE ENGINE OVER WITHOUT ANY PROBLEM. The pictures below were taken with a bore scope and show the condition of the top of the pistons, cylinder liners, and valves. All look to be in great condition with minimal surface rust. This engine was well preserved and looks to have a lot of life left in it. 6/26/2023 **Drake Charles** Date Technician Authorized Customer Representative (Print)
